Expanding Beaver Habitat in New Mexico with Low Tech Process-Based Restoration

Karen Menetrey
September 26, 2024

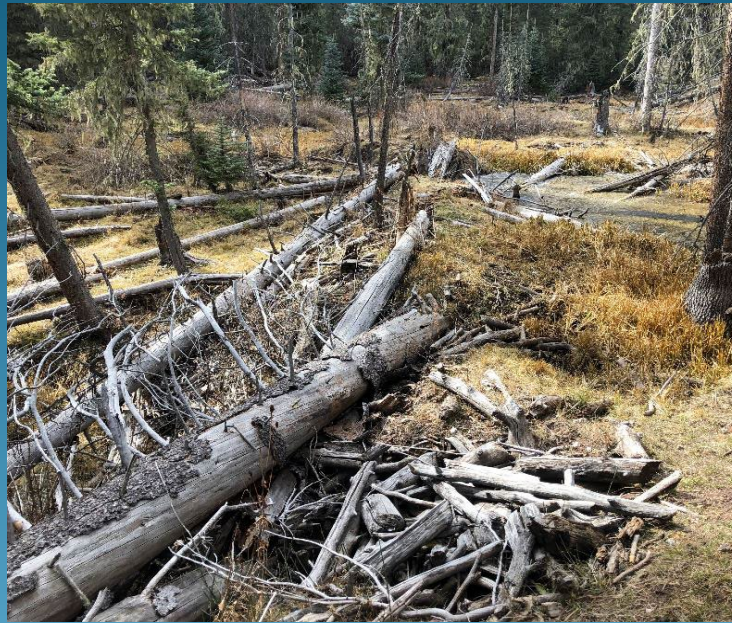
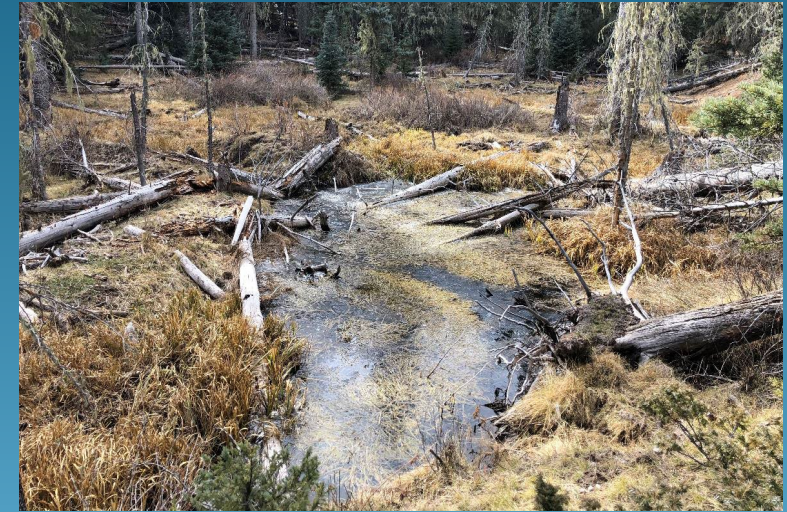
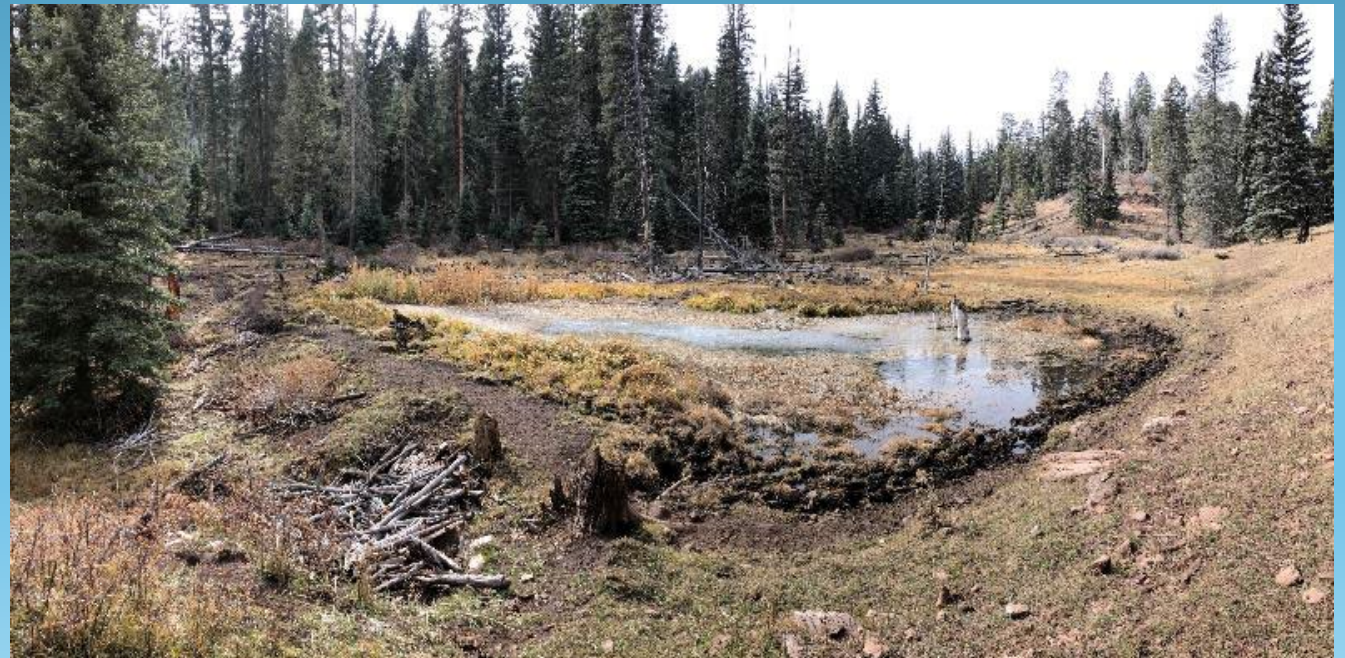
**Reference
Conditions: Jemez
Mountains, New
Mexico**

**Beaver-dominated
streams have
multiple channels
and pools that
span the
floodplain**

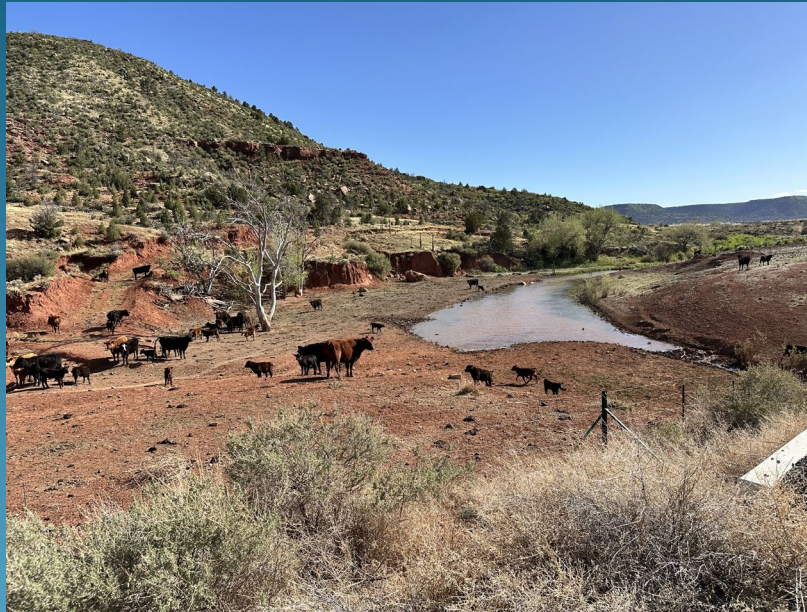
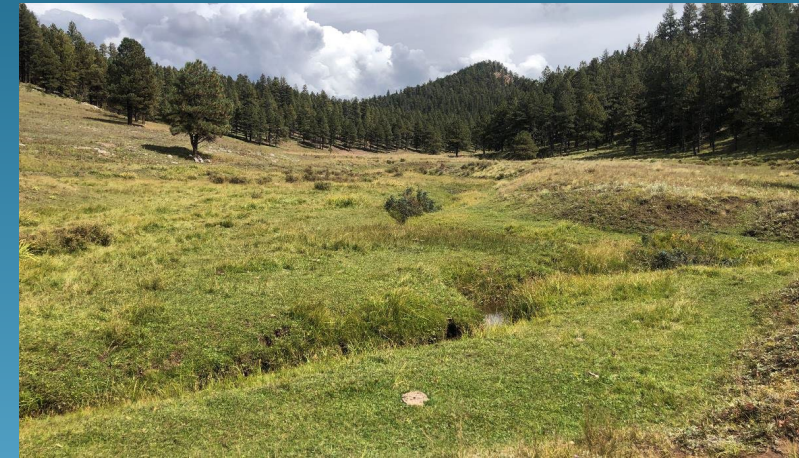
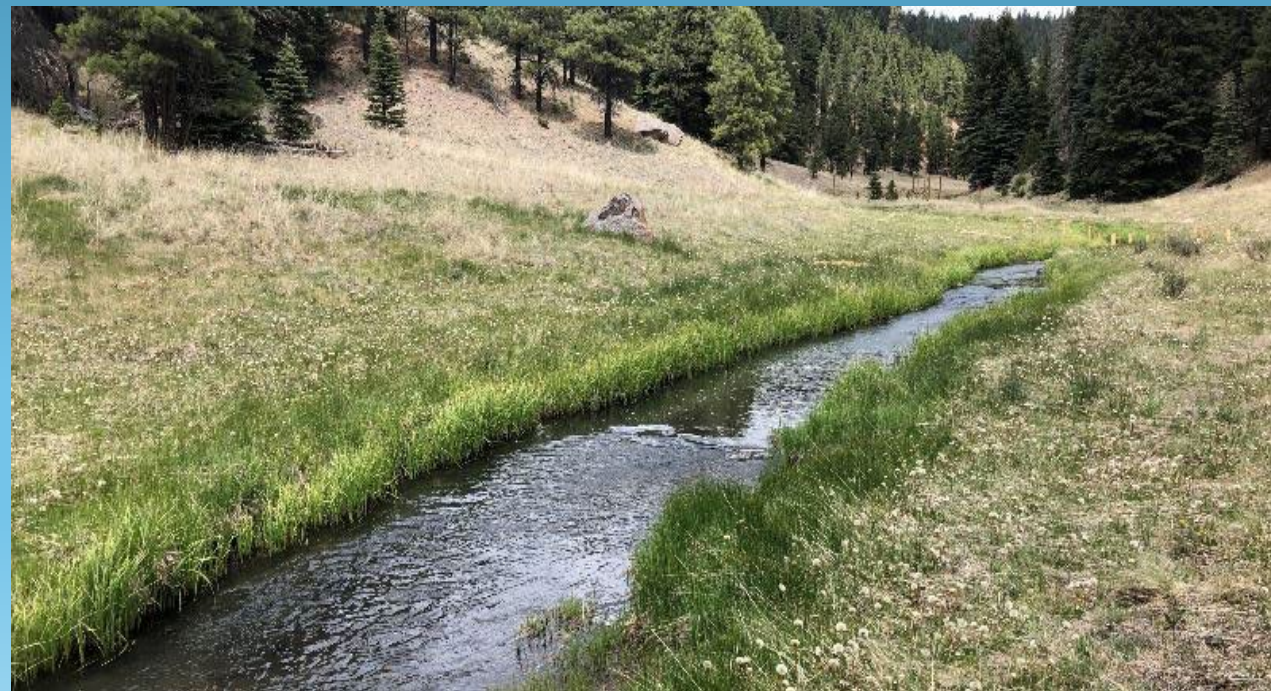
Current conditions of New Mexico's headwater streams:

Channelized and incised

Poor access to floodplain

Wood and trees/shrubs absent

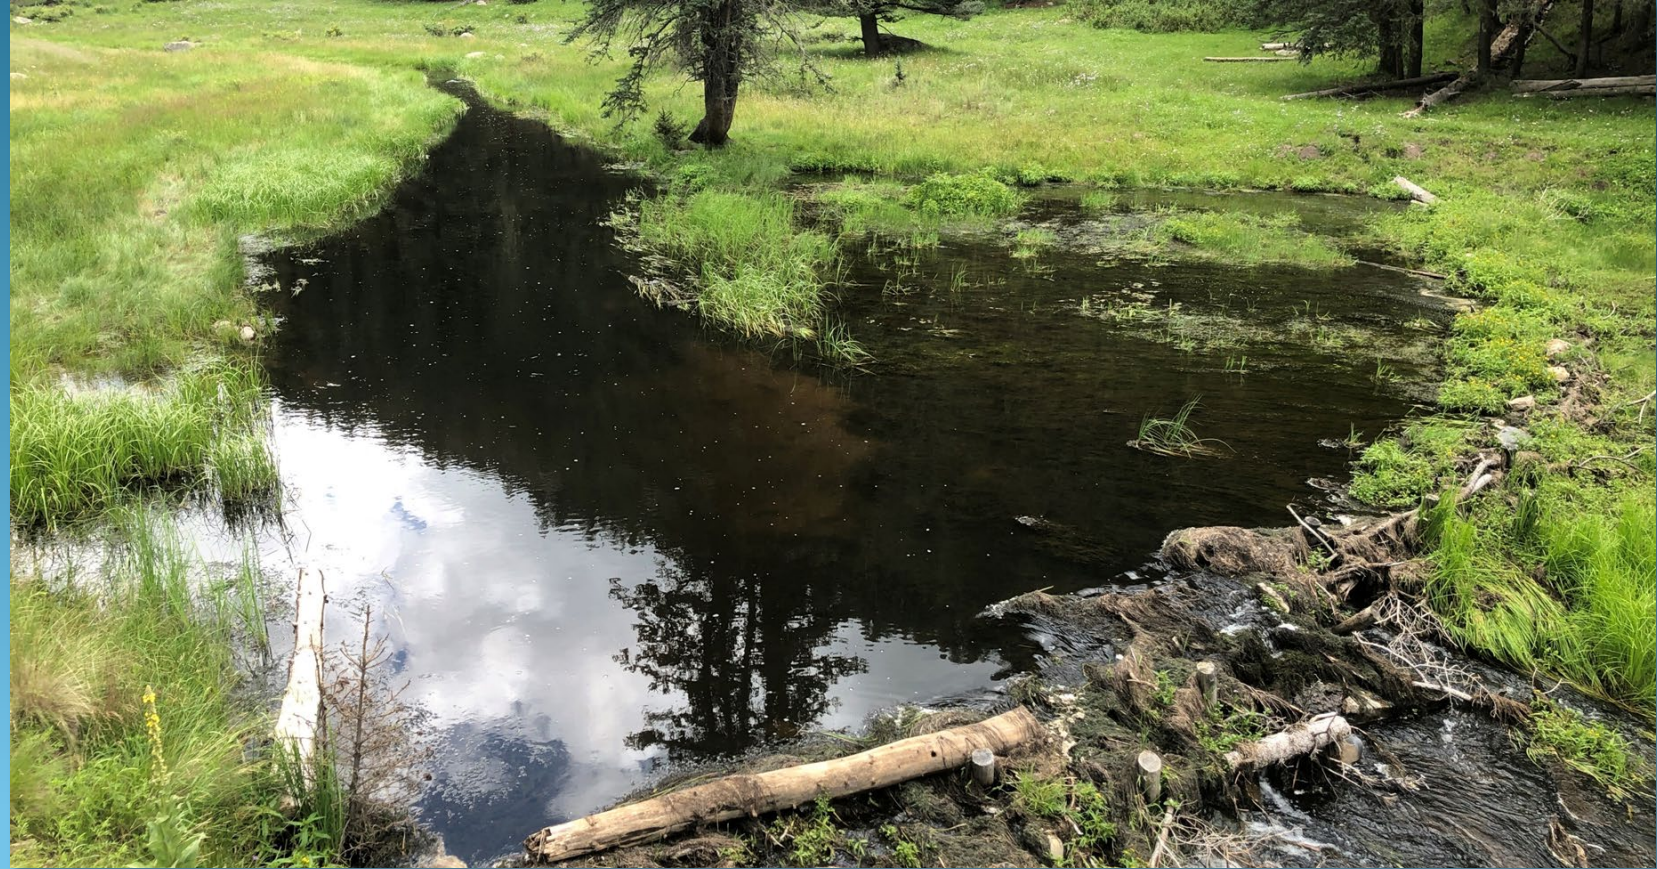
**Beaver Dam Analog,
San Antonio Creek**

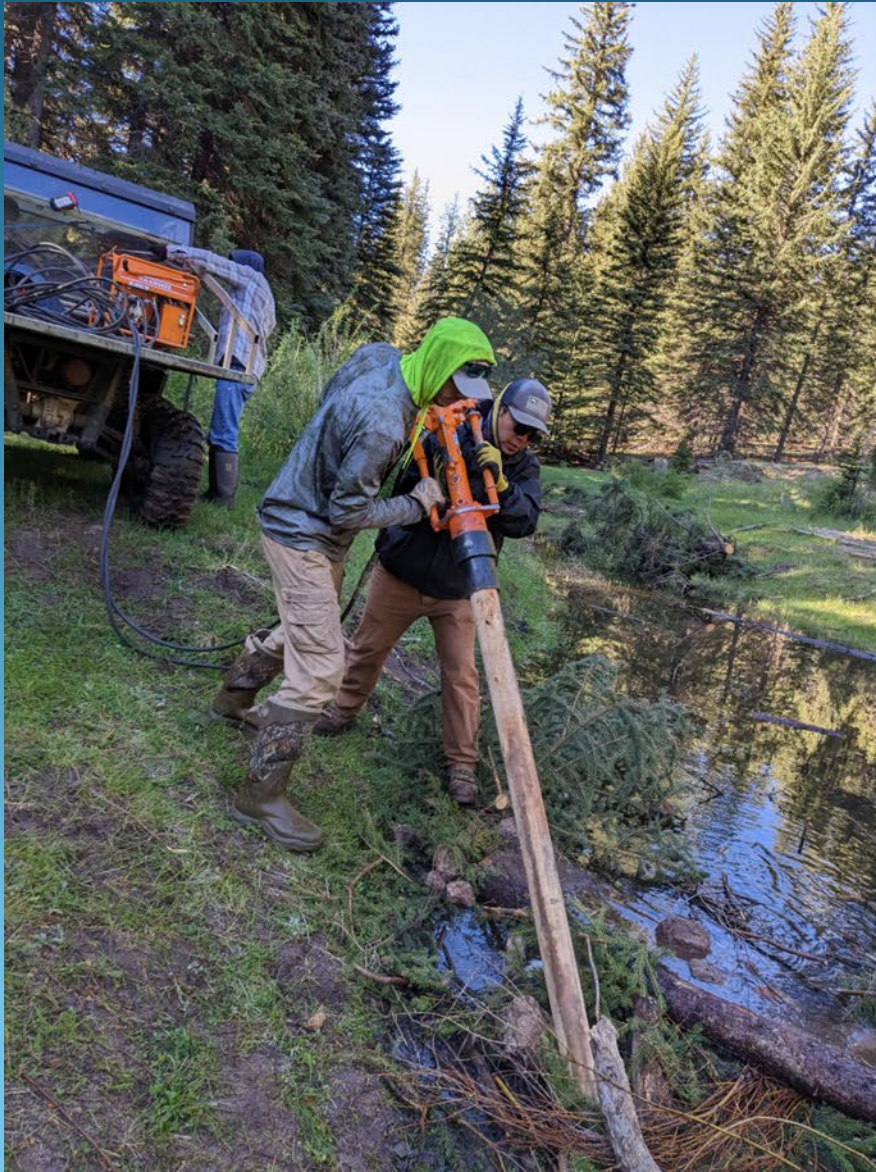
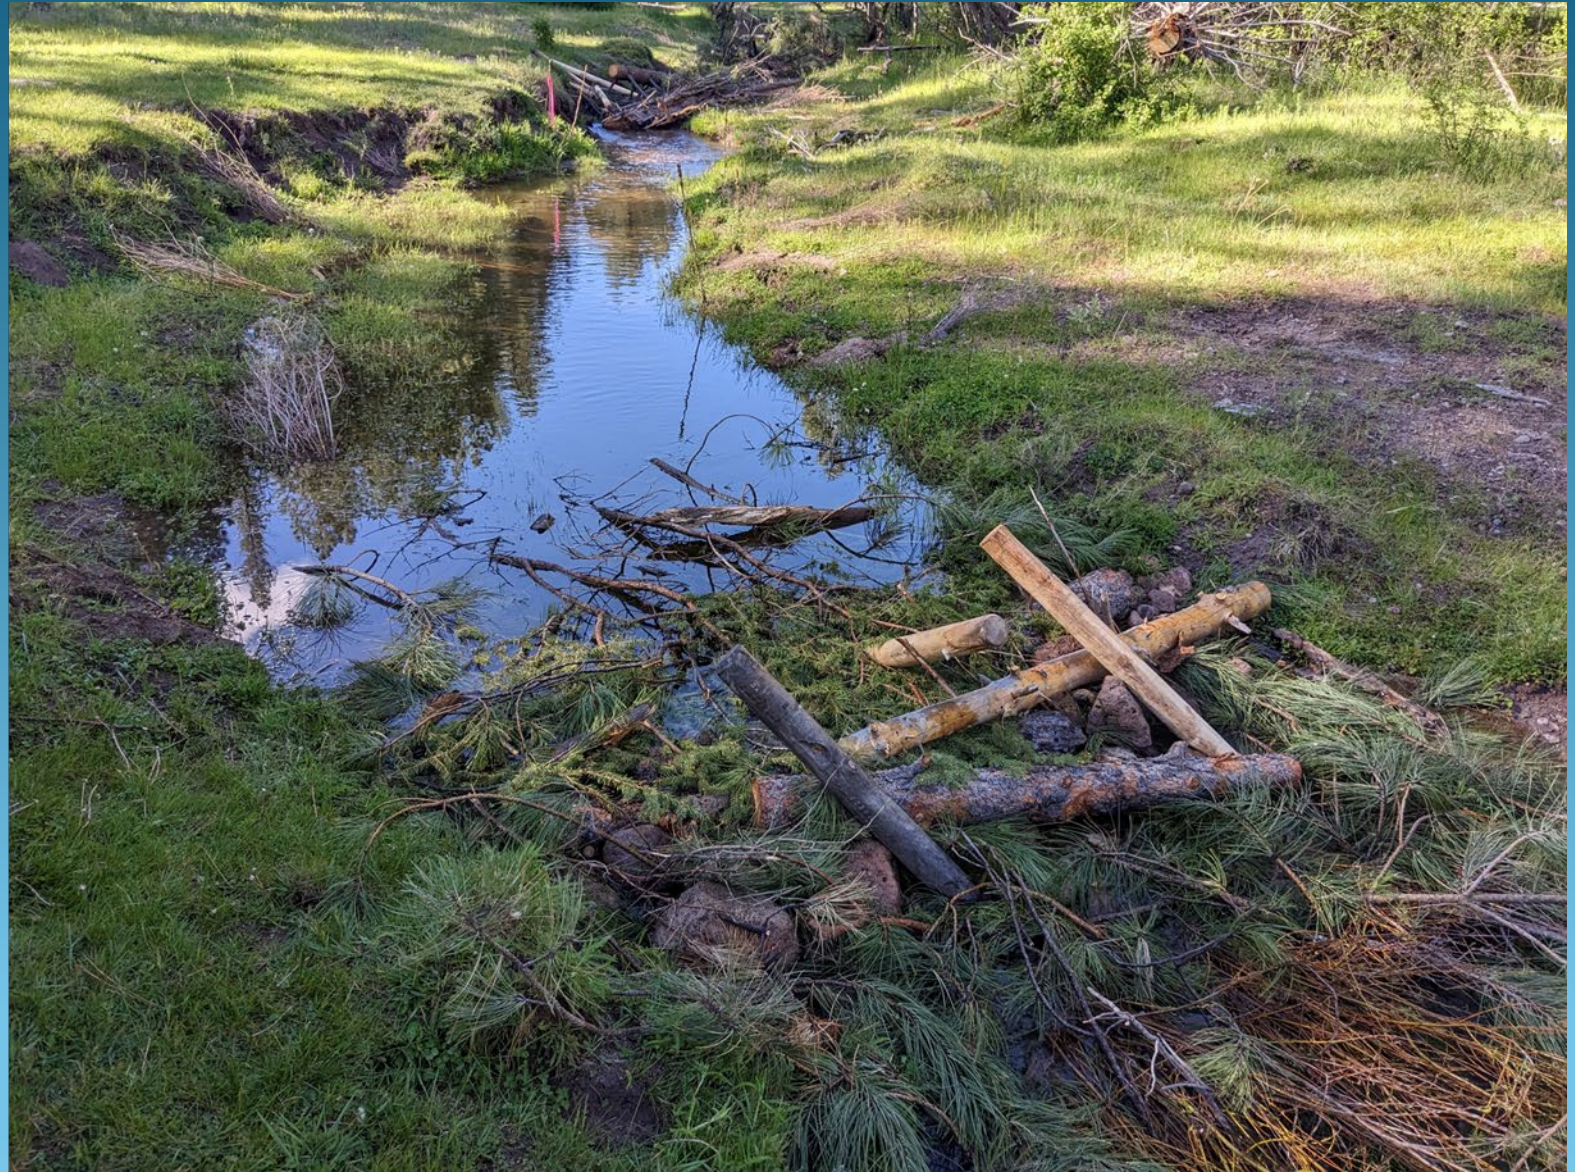
**Beaver Dam Analog,
Rito Peñas Negras** 7

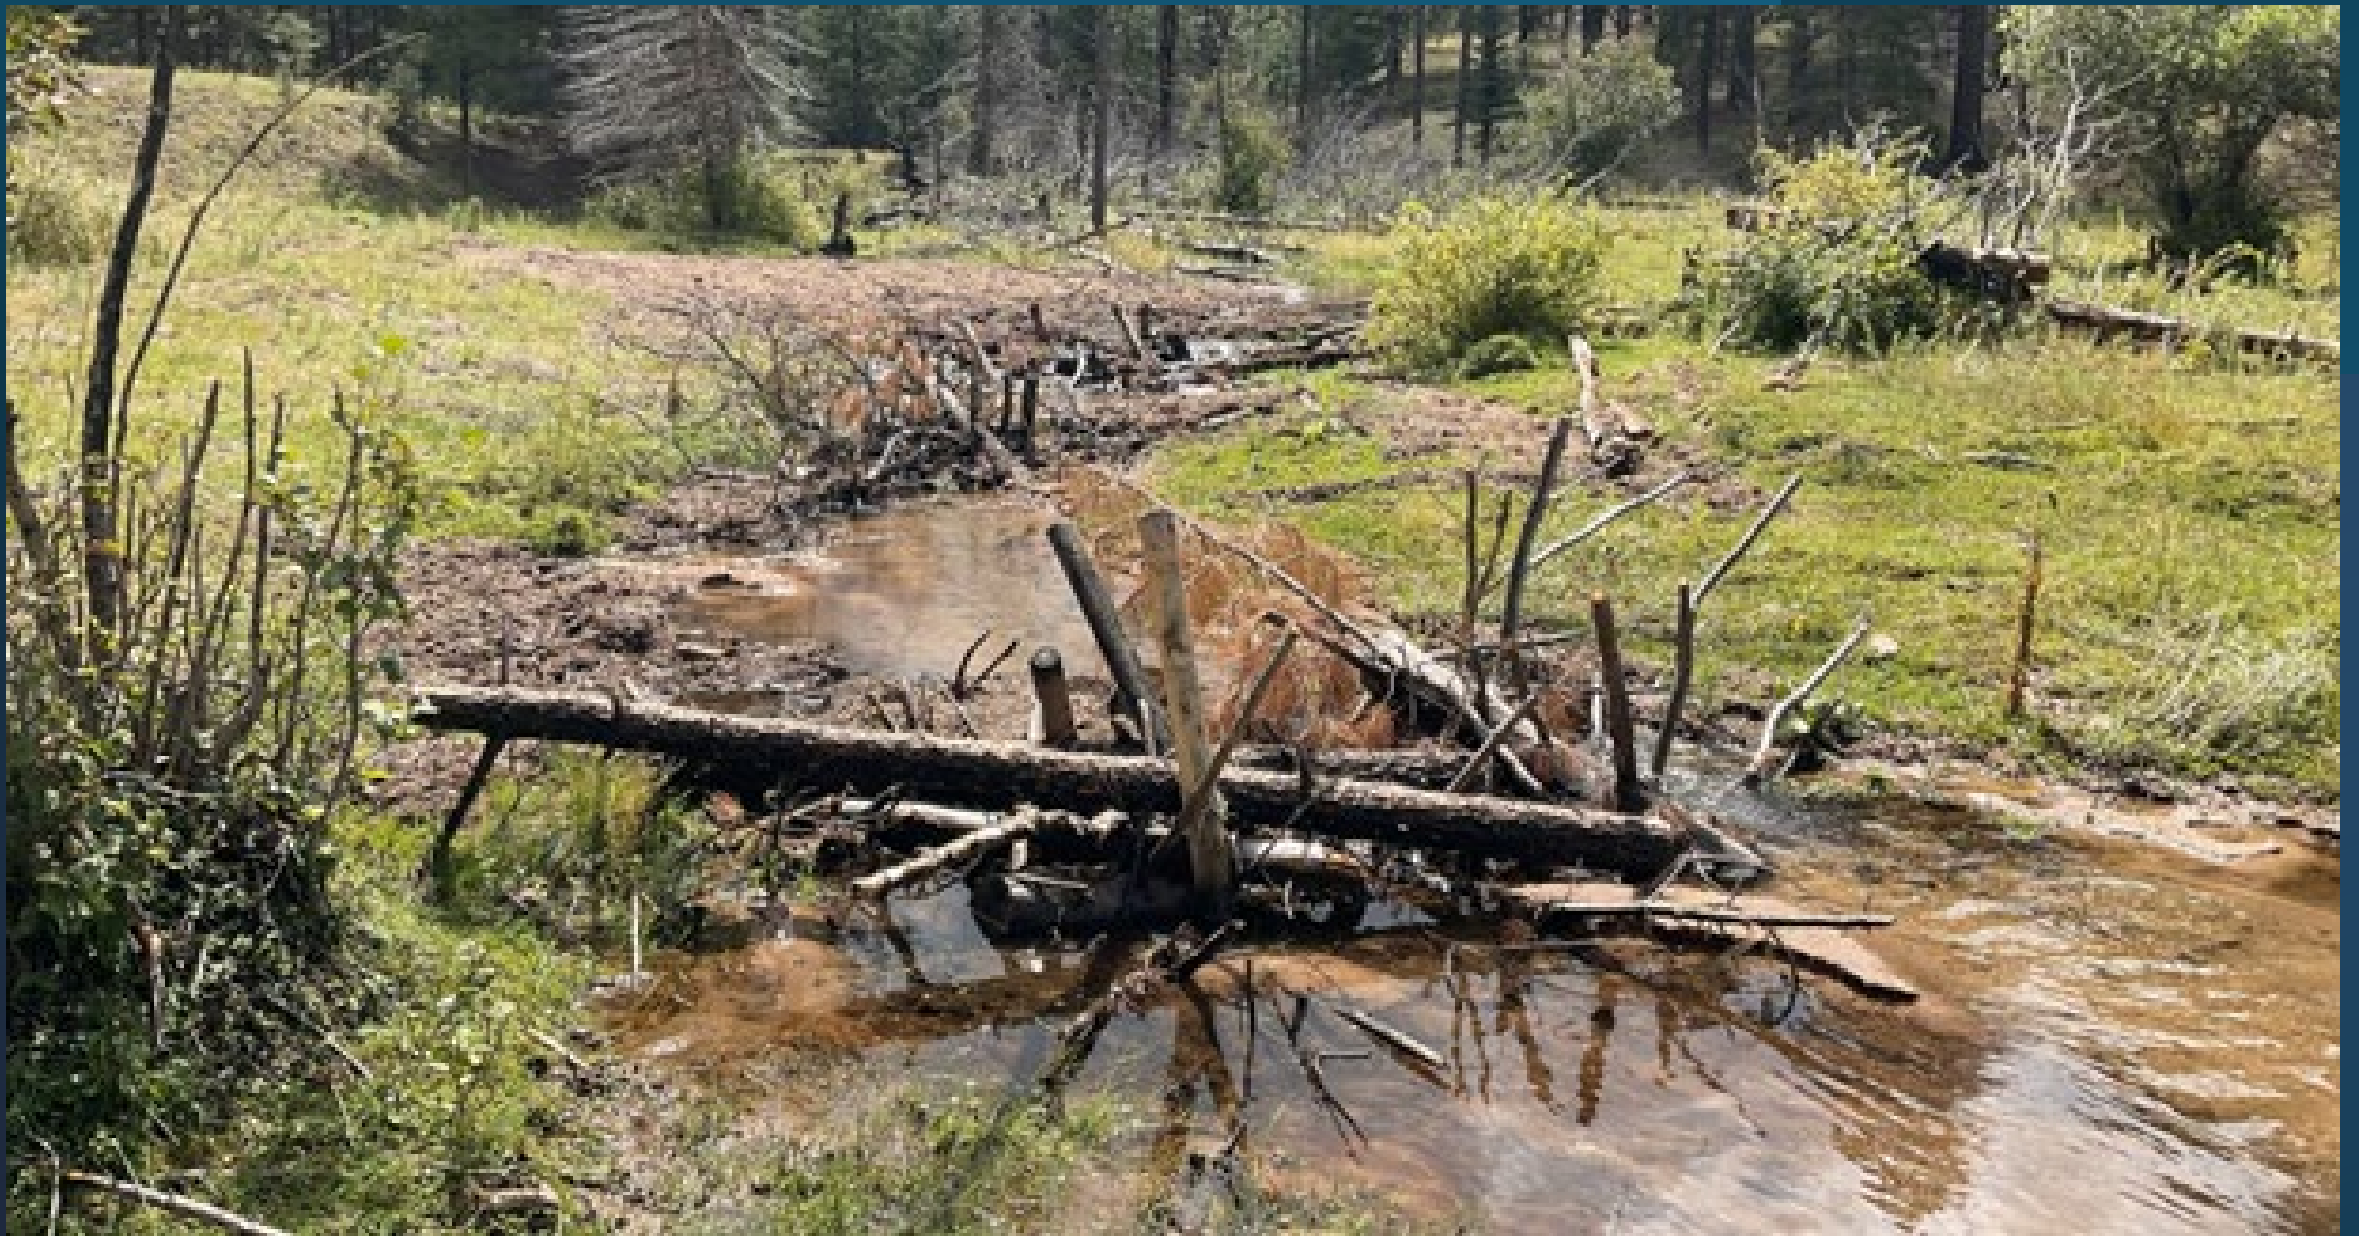
**Post-Assisted Log Structure,
Polvadera Creek**

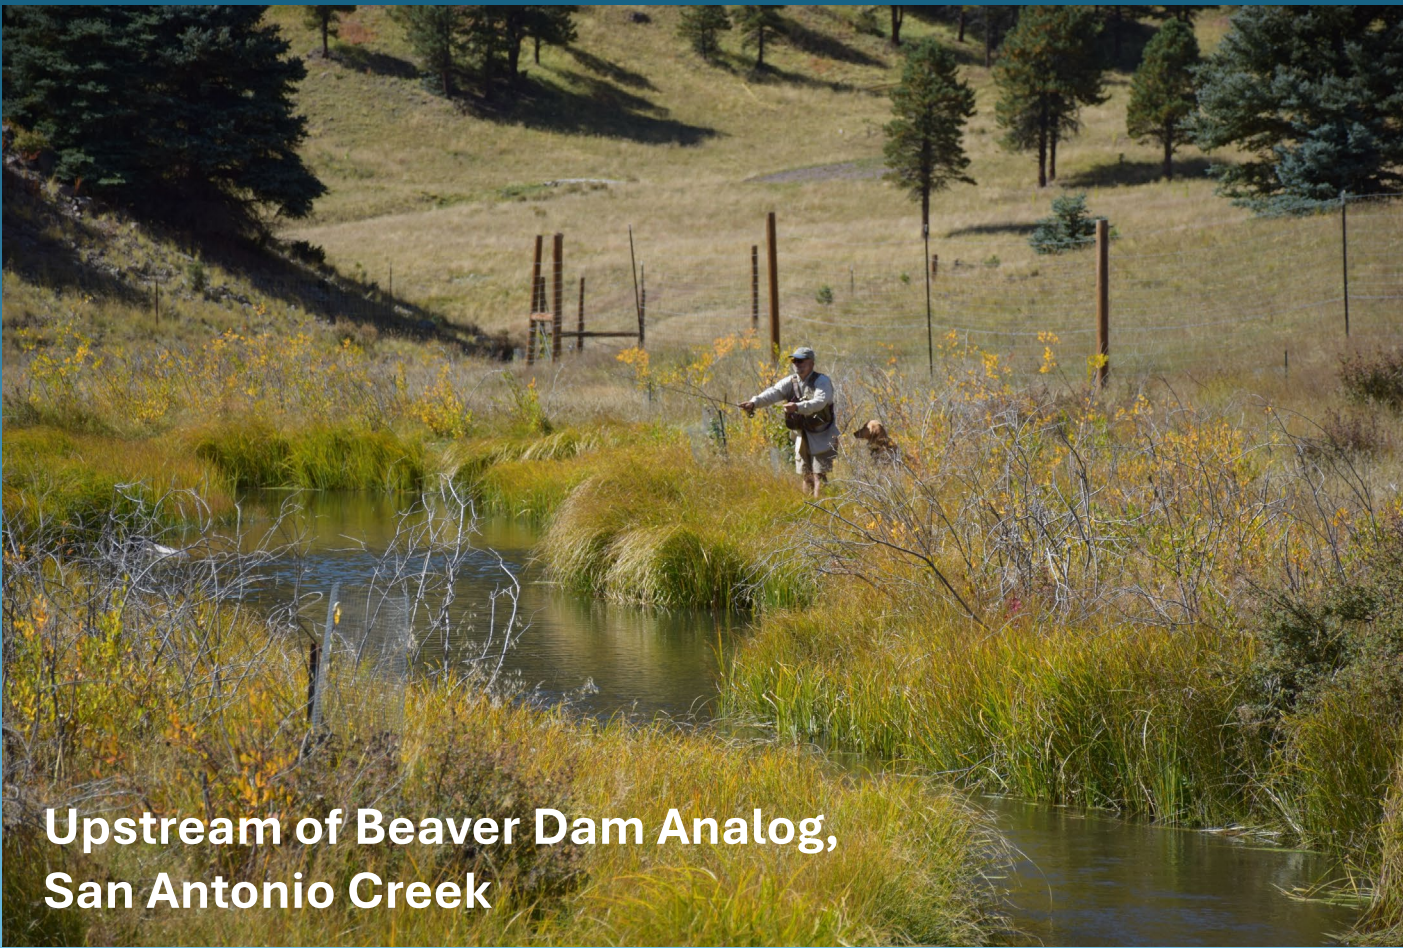
**Upstream of Beaver Dam Analog,
San Antonio Creek**
