Piedra Lumbre Visitors Center

Master Plan

June 2016

New Mexico Land Grant Council

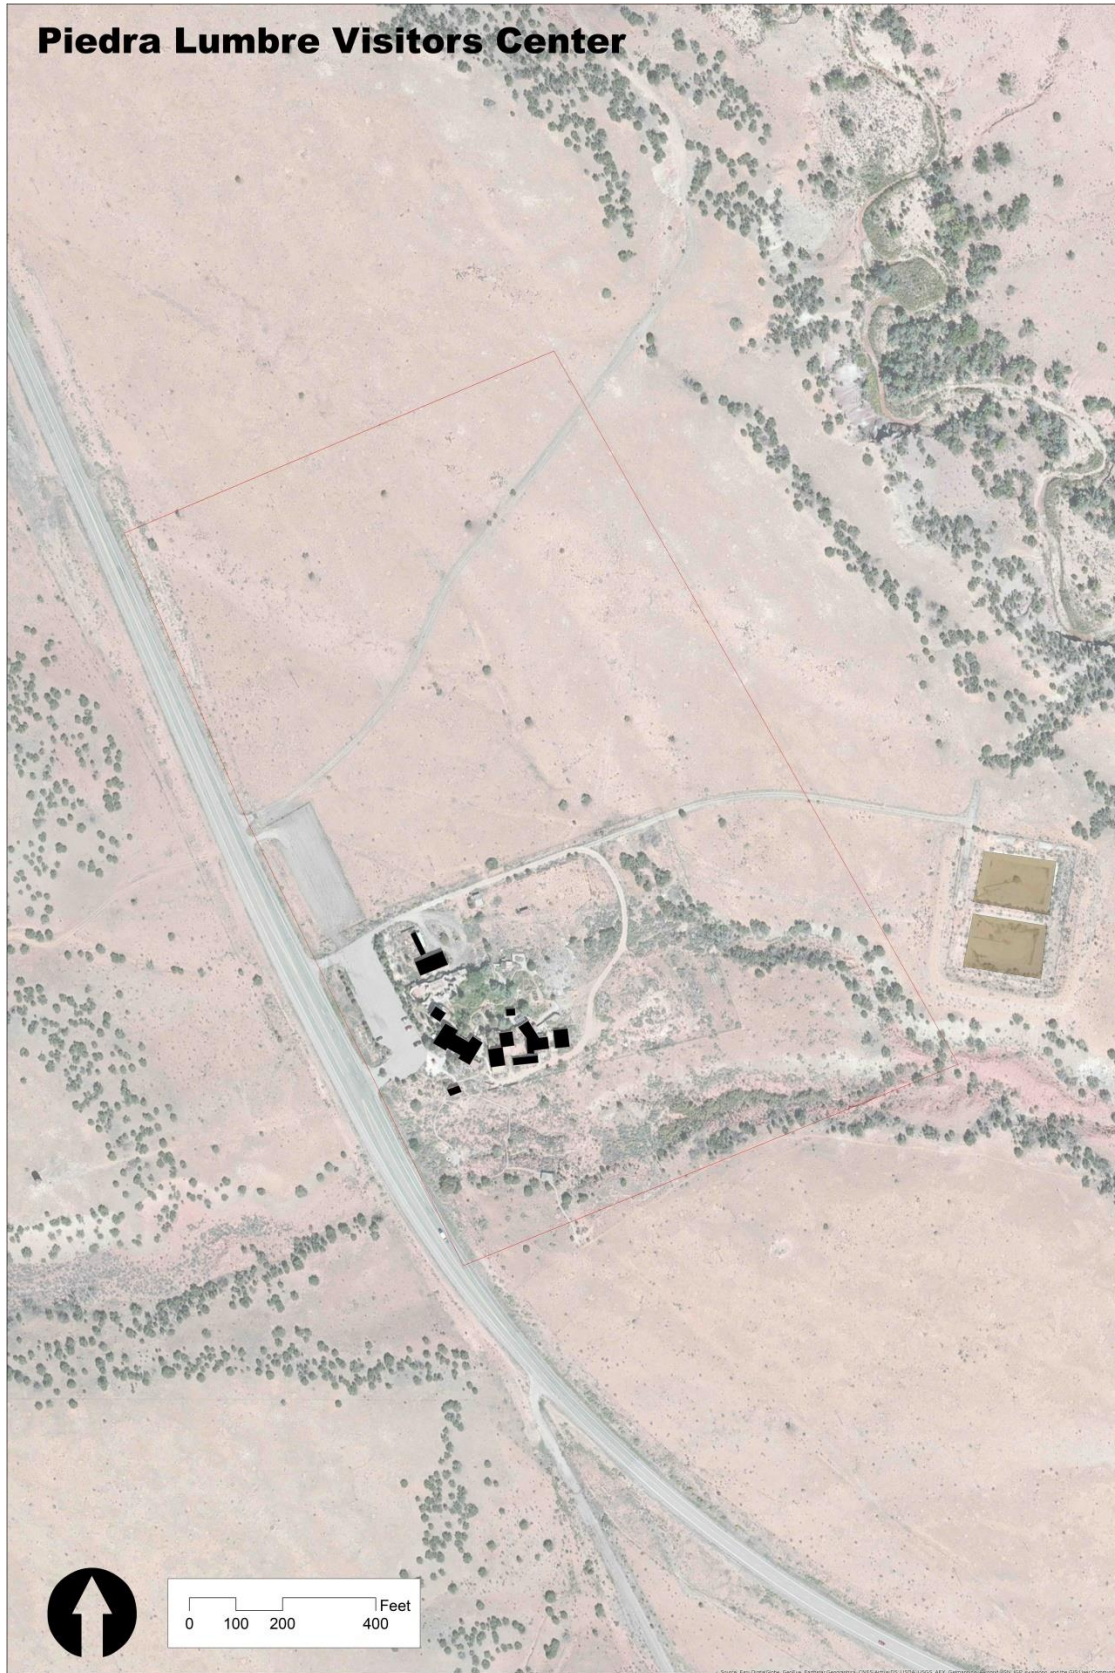
Study Area Map

For the purpose of developing a Master Plan for adaptive re-use of the PLVC for a local economic or public purpose. A full analysis was conducted regarding the existing site conditions for infrastructure, soil, slope, building inventory as well as the estimated current market value of the PLVC site. Although the existing site of the PLVC occupies approximately 10 acres of land, a forty acre study area was defined based on the current federal guidelines regarding disposal of Forest Service lands. For that purpose, the study area was defined as 40 acres including the majority of the existing facilities in the PLVC except for the storage tank west of NM 84 as well as the waste water storage lagoons which are actually located on property owned by ghost ranch. Therefore, the study area includes 40 acres including the core complex of the PLVC and vacant land to the North of the site.

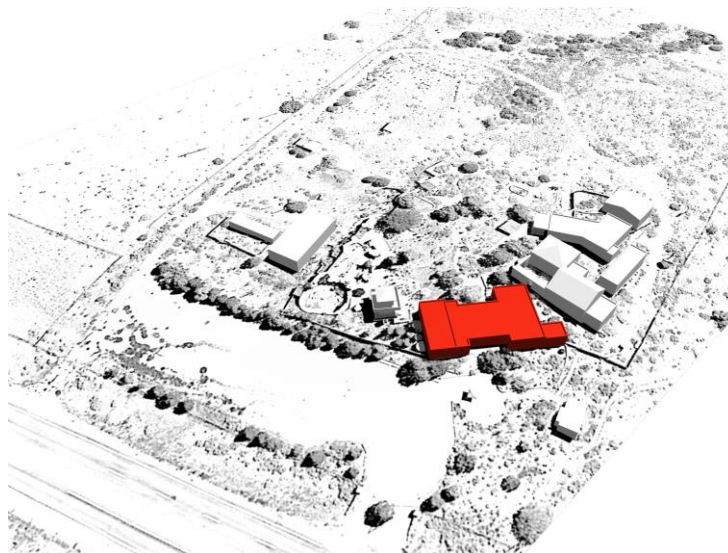
Exterior Portal facing the North

1. Main Entry/Gift Shop/Exhibit Hall/Office Space/Restroom = 3,163 square feet. Constructed late 1950’s/early 1960’s. Overall the buildings condition is graded as a “C+”. It’s marginal value for rehabilitation/ renovation is enhanced by it’s central location on the site, it’s size and plumbing infrastructure. Wood frame construction over concrete slab on grade. Stucco exterior with painted plaster / gypsum wallboard interior. Painted steel sheet “pro panel” roofing (low slope). Mix of single paned and double paned glazing. Mix of sheet flooring, carpet, etc.

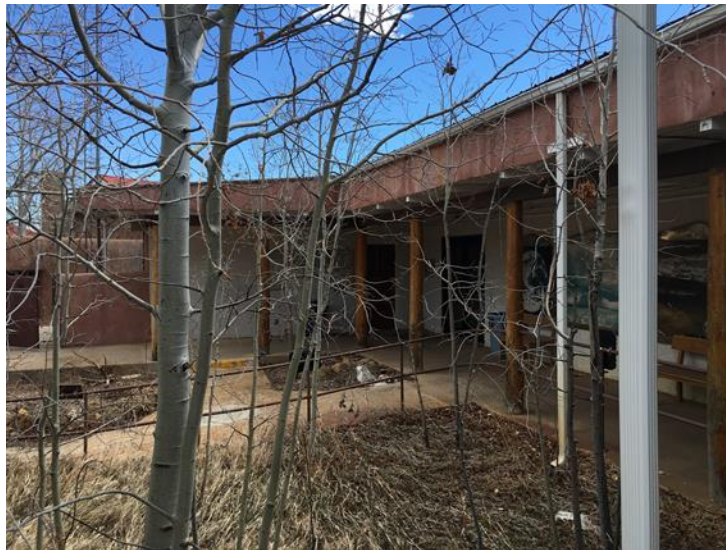
Evidence of roof failure on the northwest corner of the building, note the 1:12 or less slope of the painted steel sheet roofing.

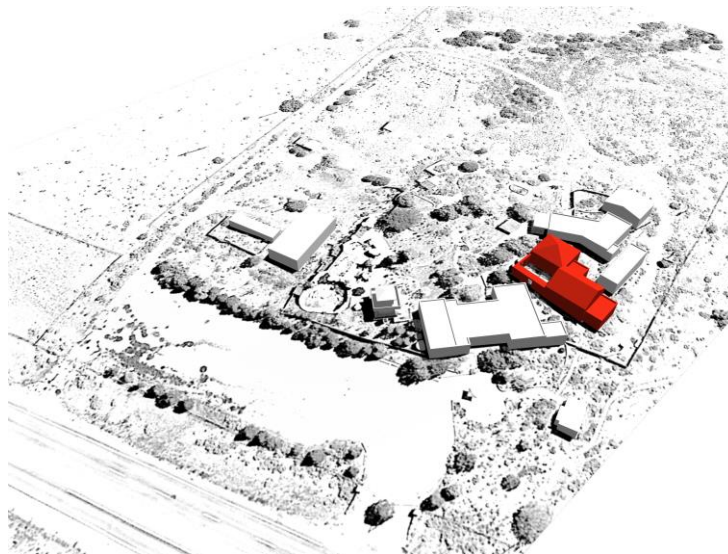
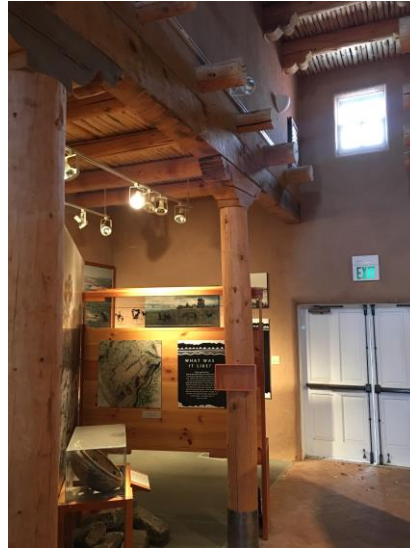
Entry Courtyard

2. Gateway Museum/Exhibit/Auditorium/Office space/Restrooms = 2,531 square feet. Constructed late 1980s. Overall this building is graded as a “B”. It is the most recent and substantial building of the group. Adobe walls with cement stucco exterior and plaster interior are in good shape. Exposed wood Column and Vigas structure have worn well. The painted steel sheet roofing here is deployed on a steep slope (>3:12) and is consequently performing much better.

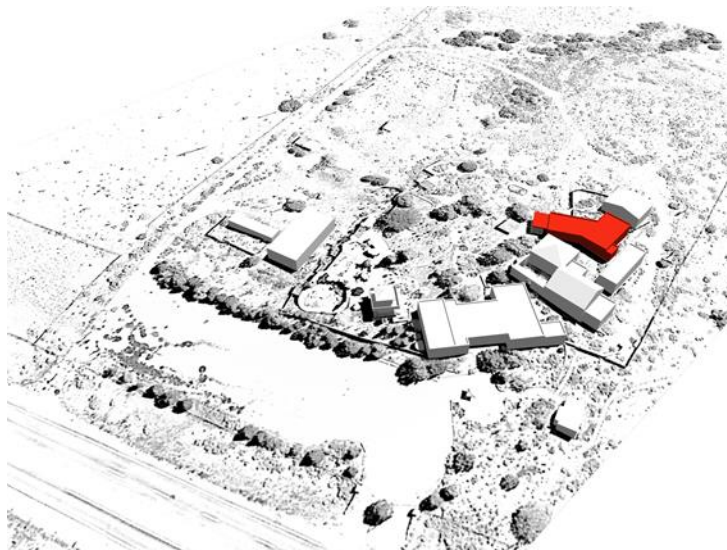
3. Beaver Museum (1,342 sq. feet)/Residence Apartment/Old Well House (1,570 sq. feet). Constructed late 1950's/early 1960's. Overall this building is graded as a "C-". Wood frame construction over concrete slab on grade. Stucco exterior with painted gypsum wallboard interior. Painted steel sheet "pro panel" roofing (low slope). Single paned steel casement windows. Mix of sheet flooring, carpet, etc.

Exterior- single paned steel casement windows, evidence of stucco deterioration.

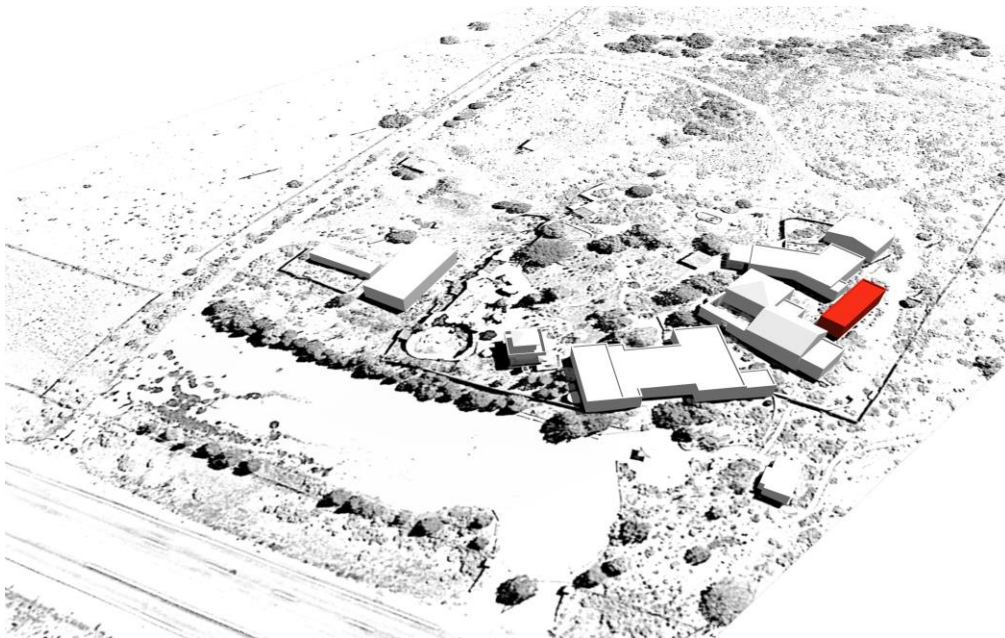
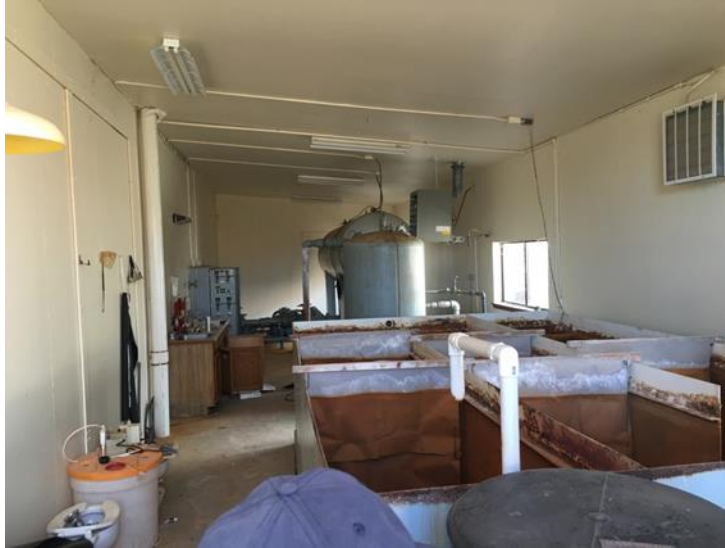
Interior View

5. Water Treatment Building = 1,056 sq. feet. Constructed 1970s or 1980s. Overall this building is graded as a “C+”. Wood frame construction over concrete slab on grade. Stucco exterior with painted plaster / gypsum wallboard interior. BUR roofing (low slope). Mix of single paned glazing. Exposed concrete flooring.

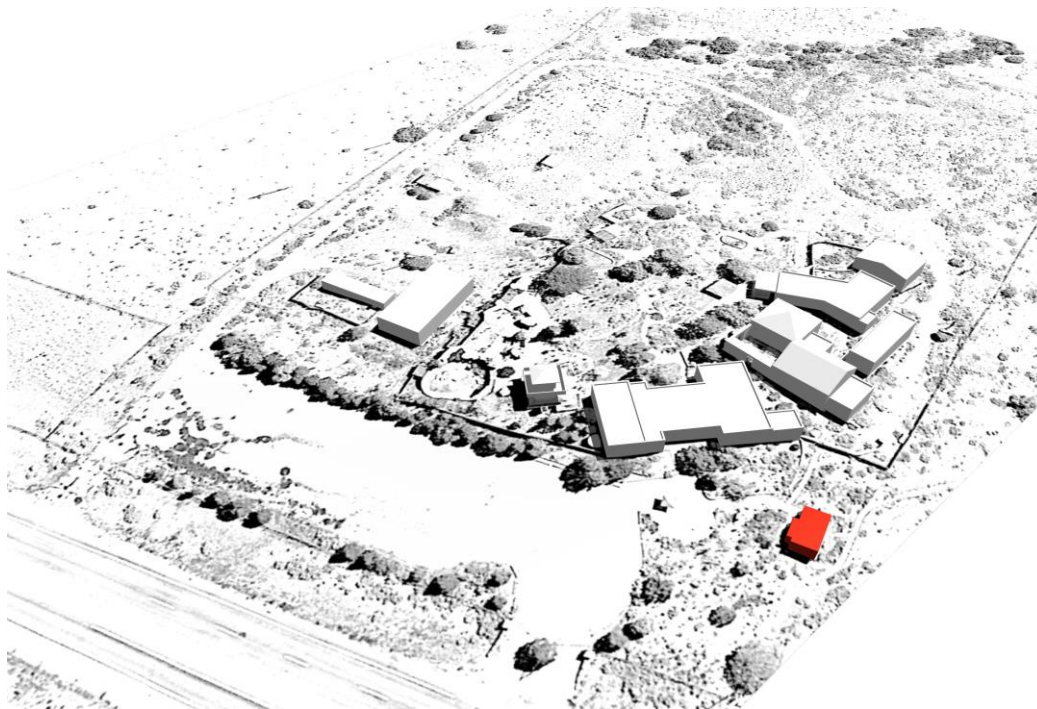
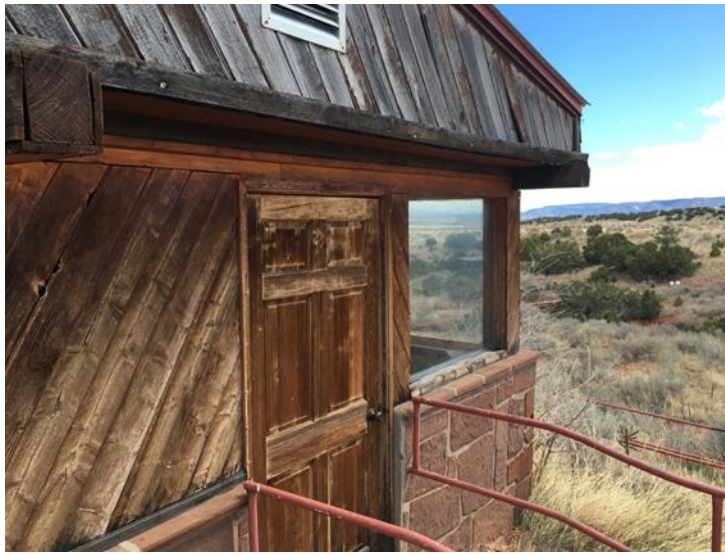
Entry

6. Range Exhibit = 462 square feet. Constructed 1980's. Overall this building is graded as a "C-". Wood interior/no plaster Wood frame construction over concrete slab on grade. Exterior - sandstone veneer wainscot mix of stucco and unfinished diagonal wood siding. Wood interior. Painted steel sheet "pro panel" roofing (low slope).

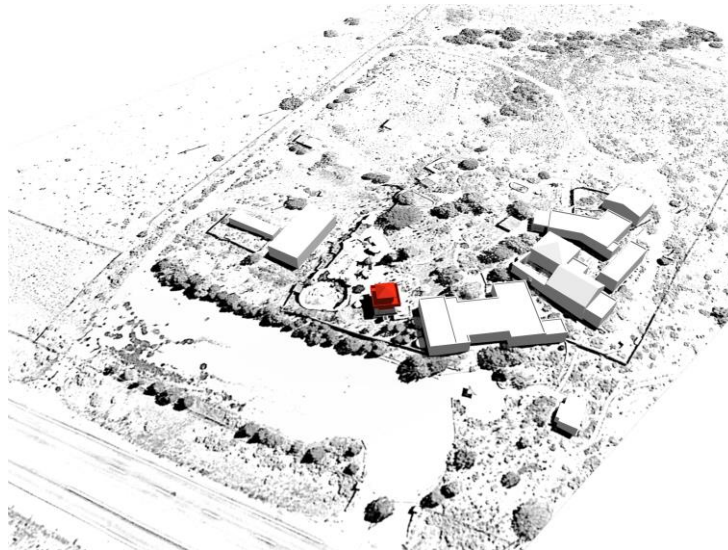
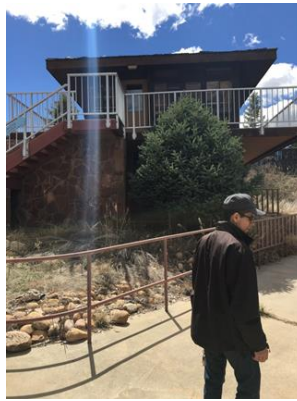
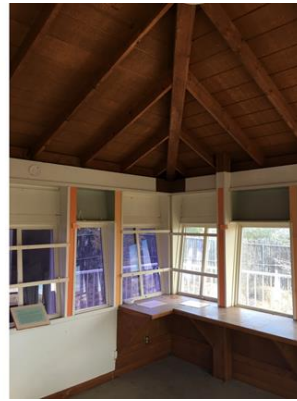
Exterior View

7. Fire Tower/Public Restrooms/Utility closet = 576 square feet. Constructed 1980s. Overall this building is graded as a "B -". Composite construction. Wood frame over concrete substructure. Sandstone veneer over concrete (lower level), painted wood siding and exposed wood structure (upper level. Glazed exterior hydraulic lift (two stops), currently non functioning. Exterior steel railing system. Wood shingle roof. Exposed wood interior. Double paned glazing.

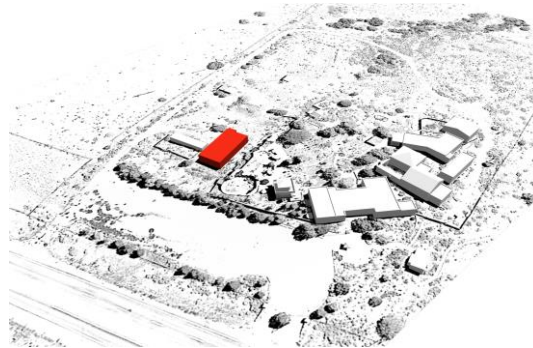
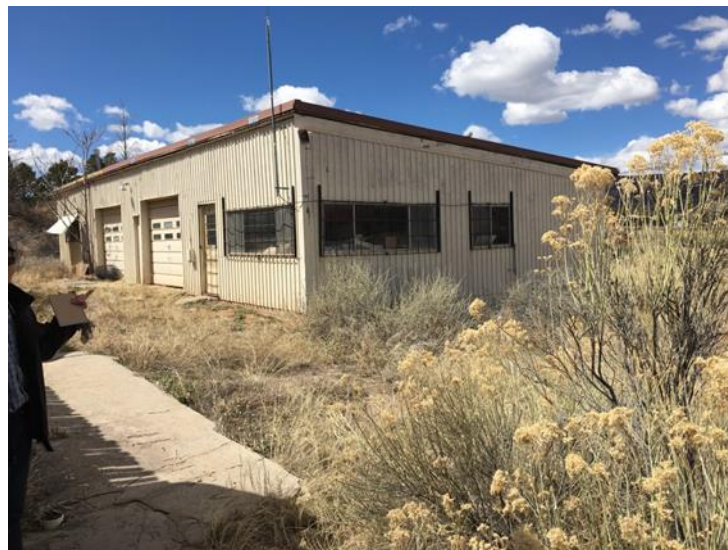
Exterior

- 8. Maintenance Building/Shop/Old kitchen/Restroom = 1,938 square feet. Constructed 1970s. Overall this building is graded as a “F”. Light gauge steel frame, sided and roofed utility construction. Significant rodent and insect infestation reported.

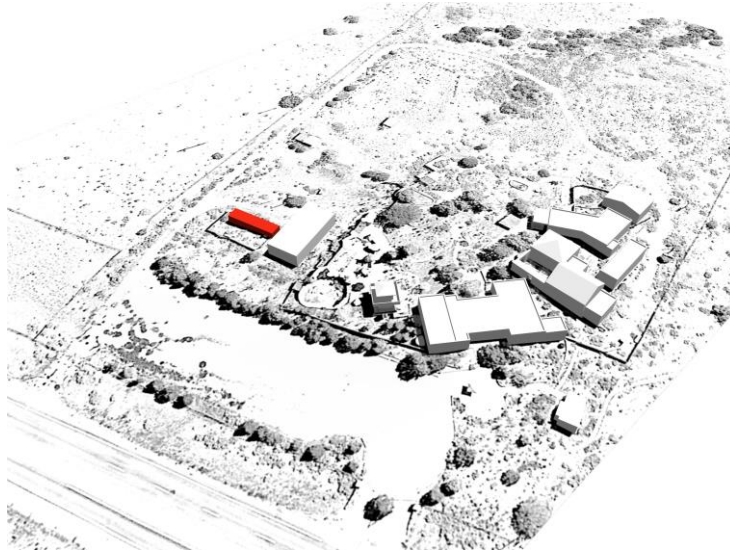
Exterior View

- 9. Single wide trailer = 460 square feet. Overall this building is graded as a “F”. Old mobile home construction. Significant rodent and insect infestation reported.

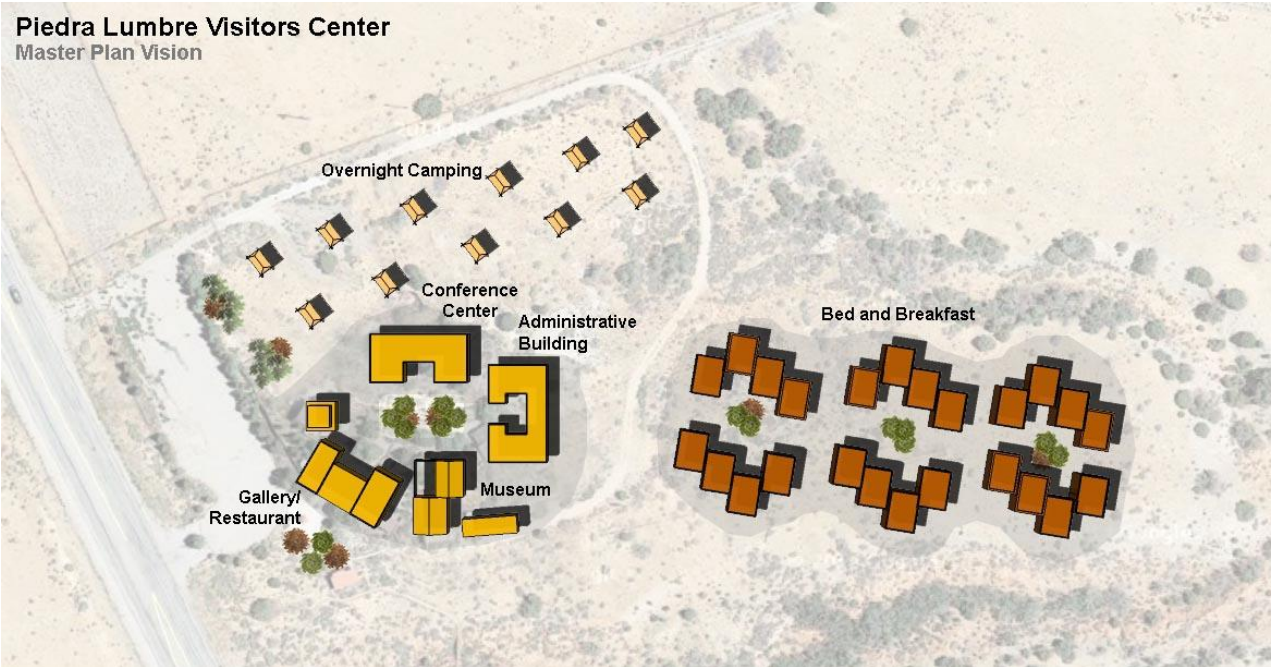
Plan View of Master Plan Vision

As part of this study, a Conceptual Master Plan Vision was developed to visualize how the PLVC site could support some of the uses options generated as part of the public process. Some of the uses visualized in the Master Plan allow for flexible use that could incorporate a conference center for community and youth programming in addition to the typical uses at the visitor’s center such as the gallery and museum uses.
