Protecting Public Health and the Environment in New Mexico from Colorado's Mining Waste

Ryan Flynn
Secretary of Environment
July 15, 2016

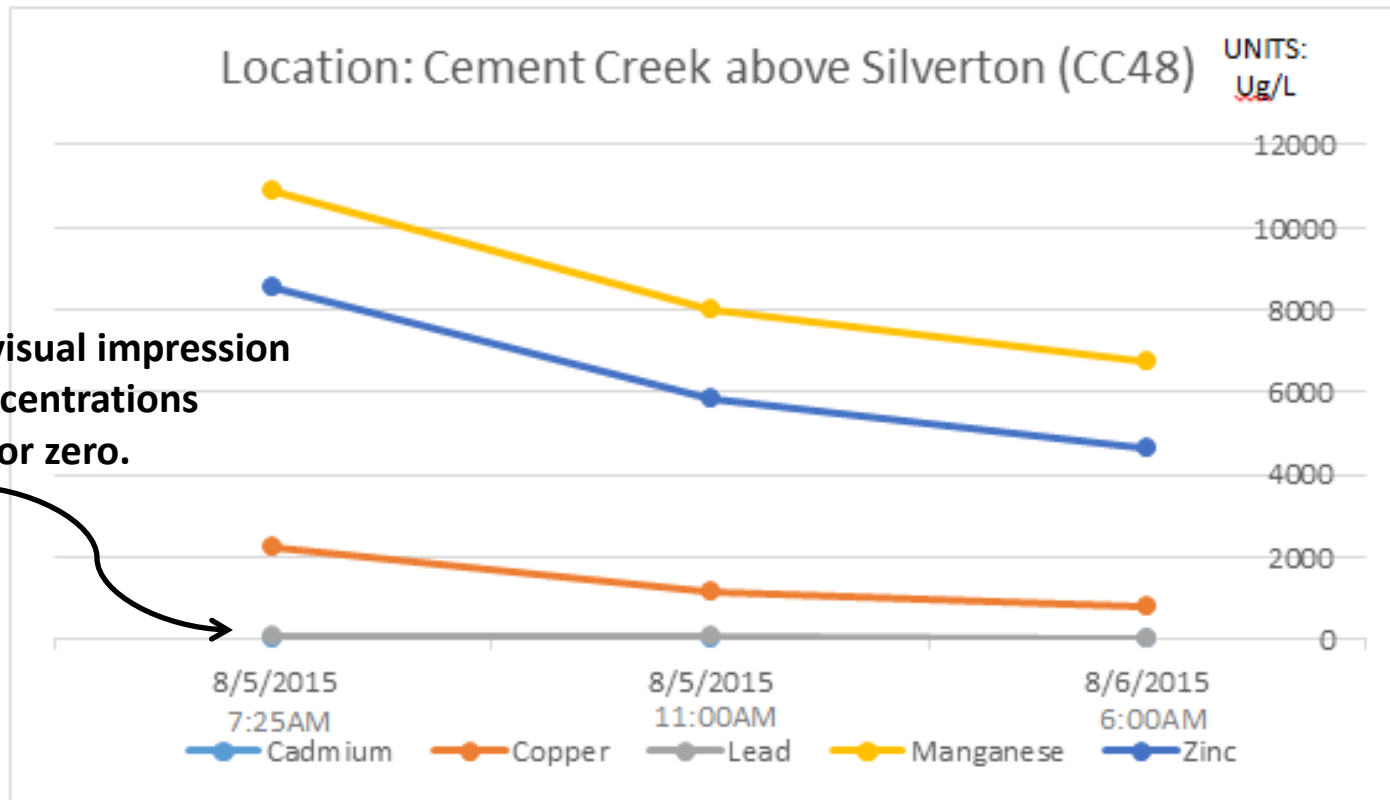
Misleading EPA Data Presentation

(Dissolved metals graph provided by EPA to NMED on August 7, 2015)

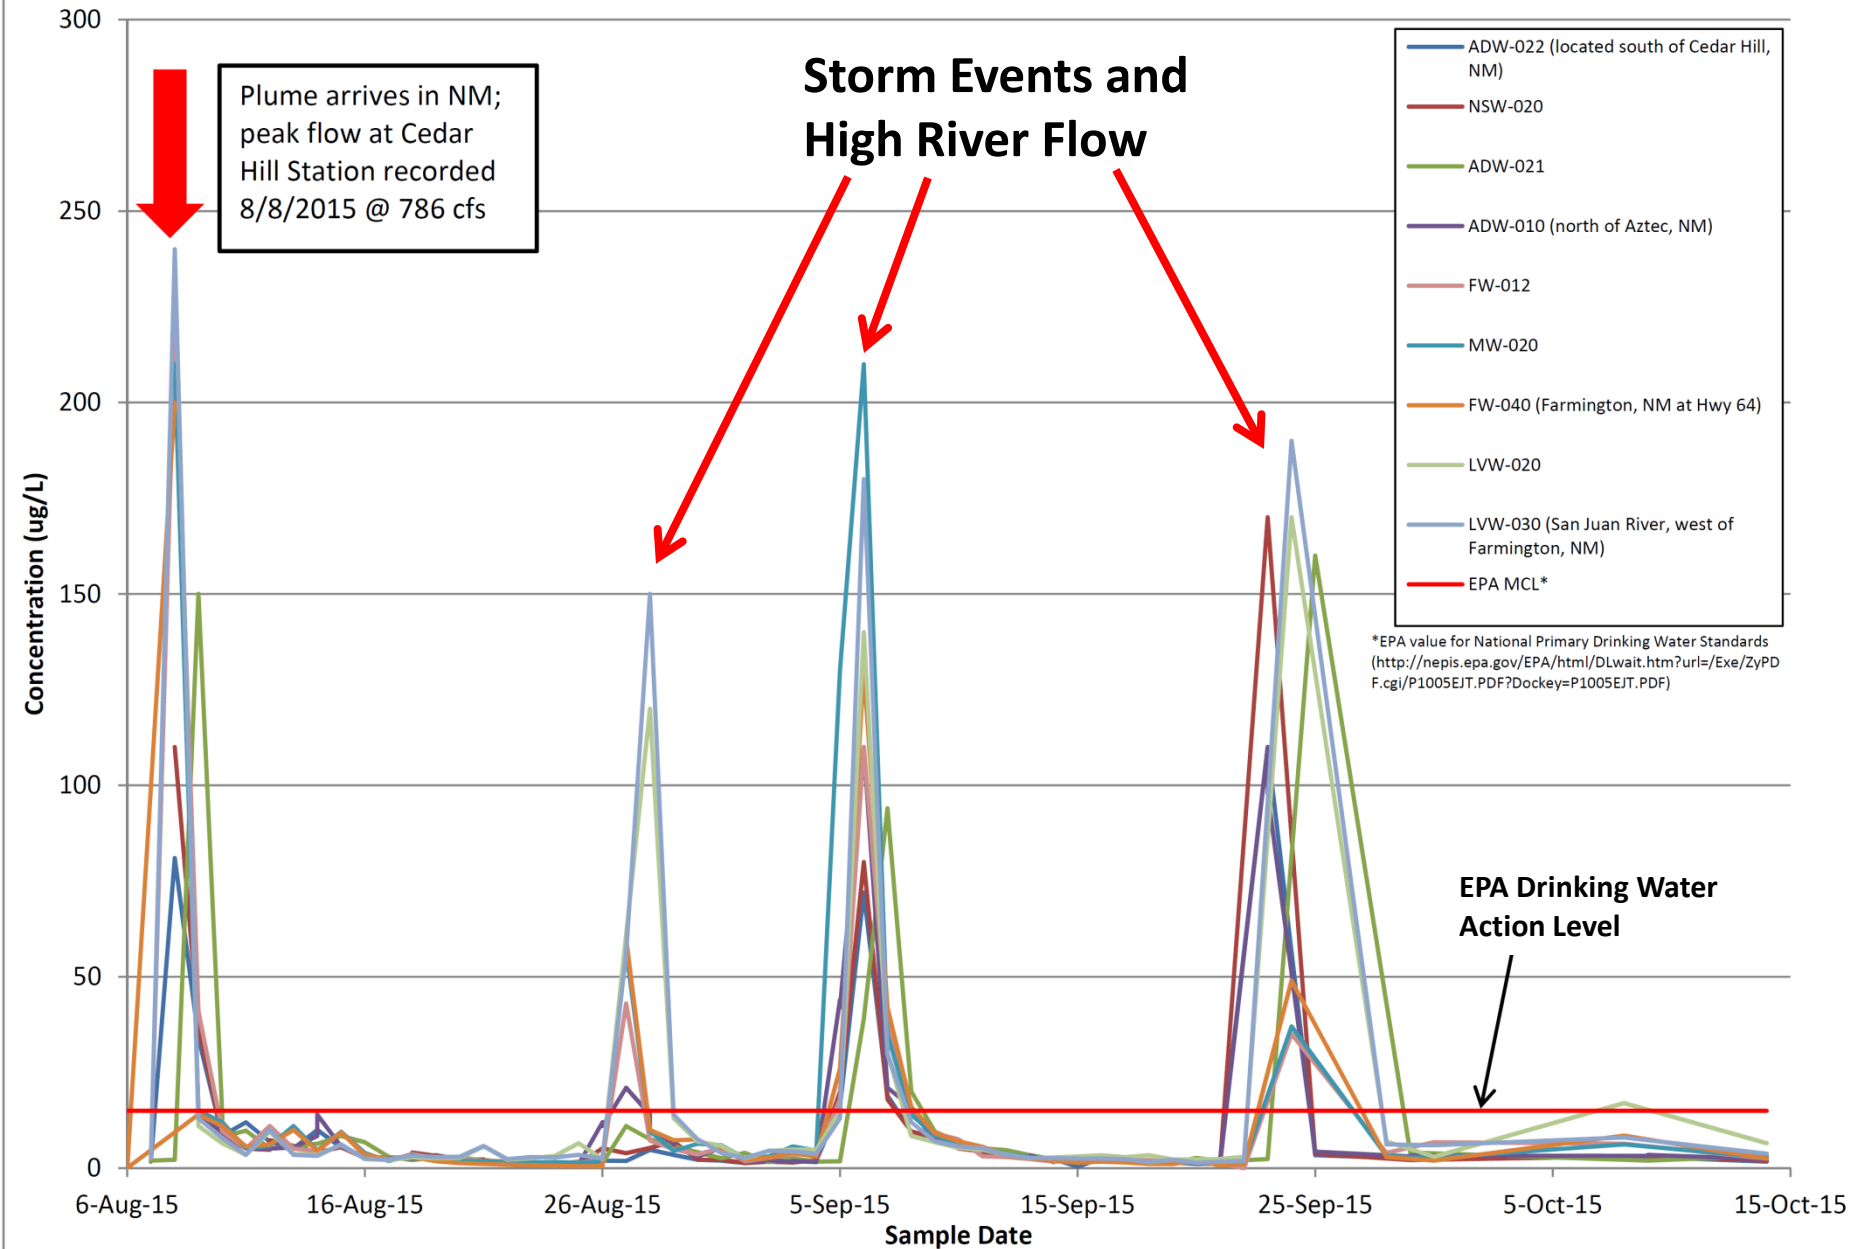
Total Lead in the Animas and San Juan Rivers New Mexico

- **The Animas and San Juan watersheds contain 1,100,000 pounds of metals that were not there on Aug. 4, 2015.**
- **EPA’s monitoring data strongly suggest that metals in surface water and sediment have not returned to pre-event conditions.**

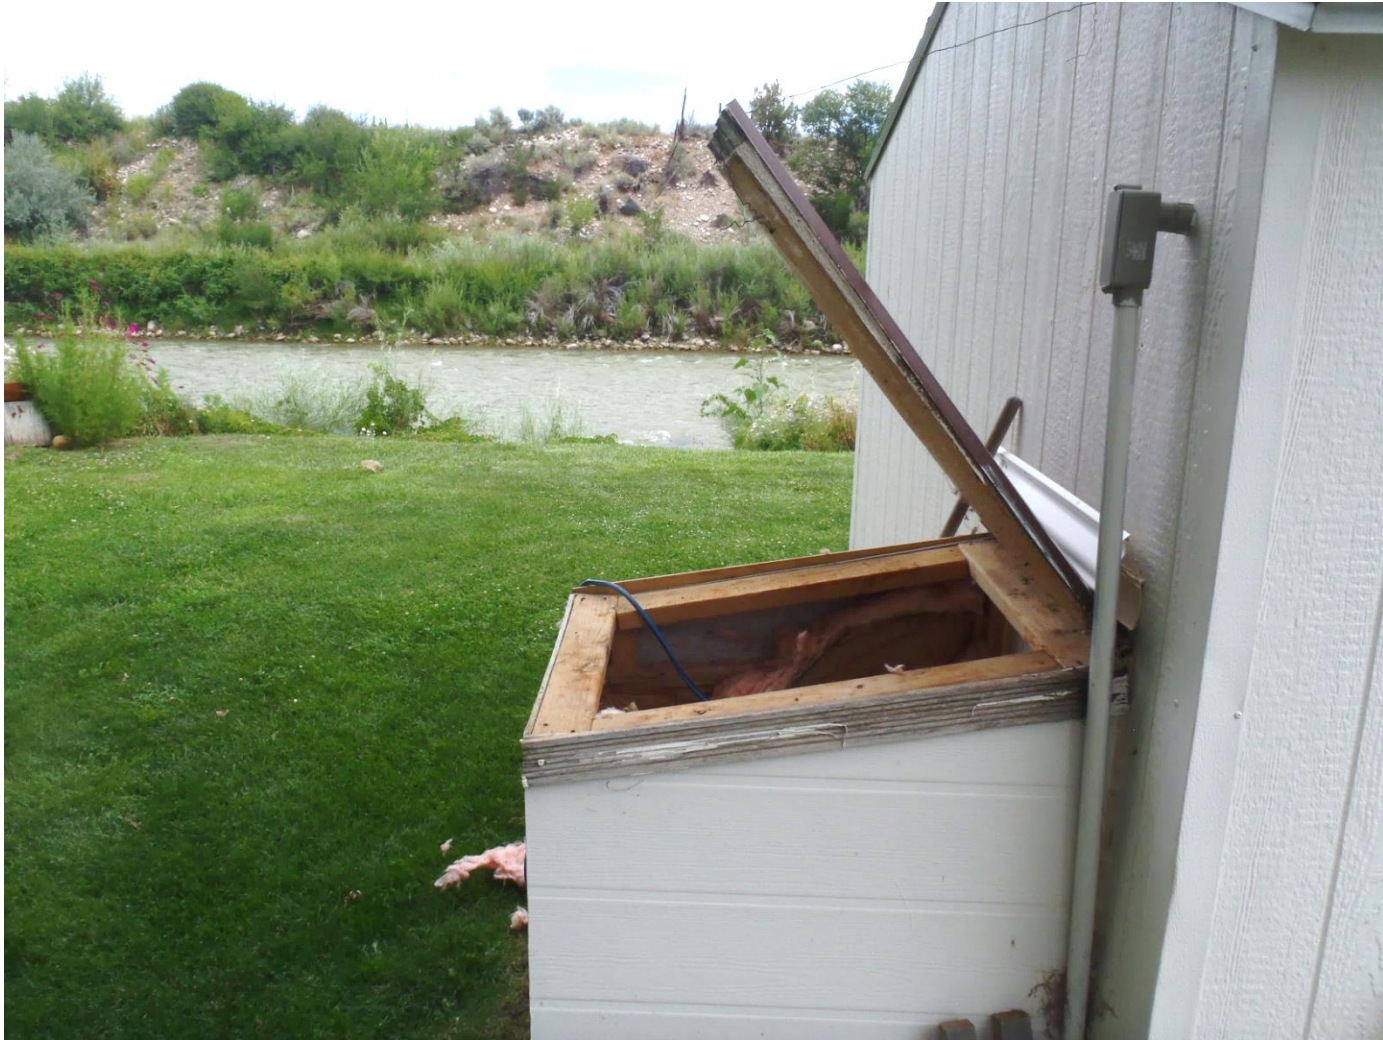
Many Families Live Along the Animas River

Residents have the river in their back yard and drink groundwater from alluvial wells.

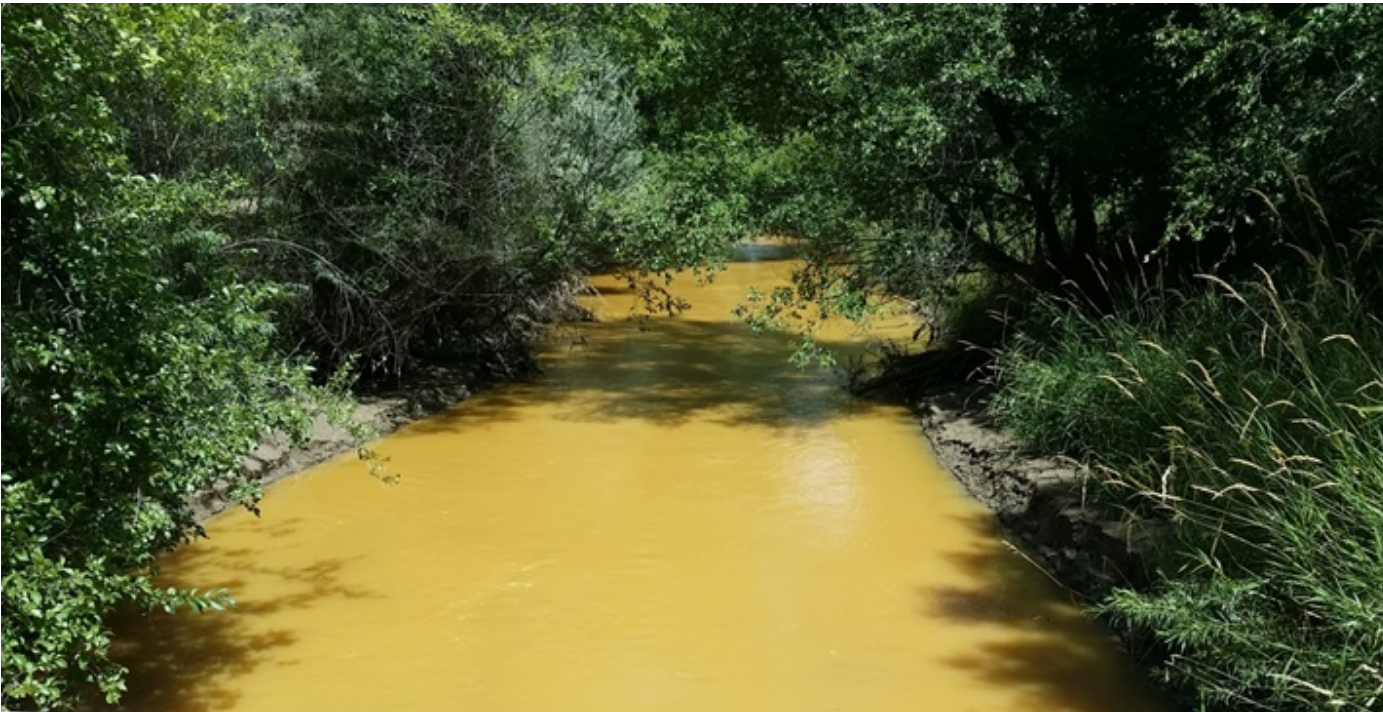
**Willett Irrigation
Ditch**

**Farmington, NM
August 8, 2015**

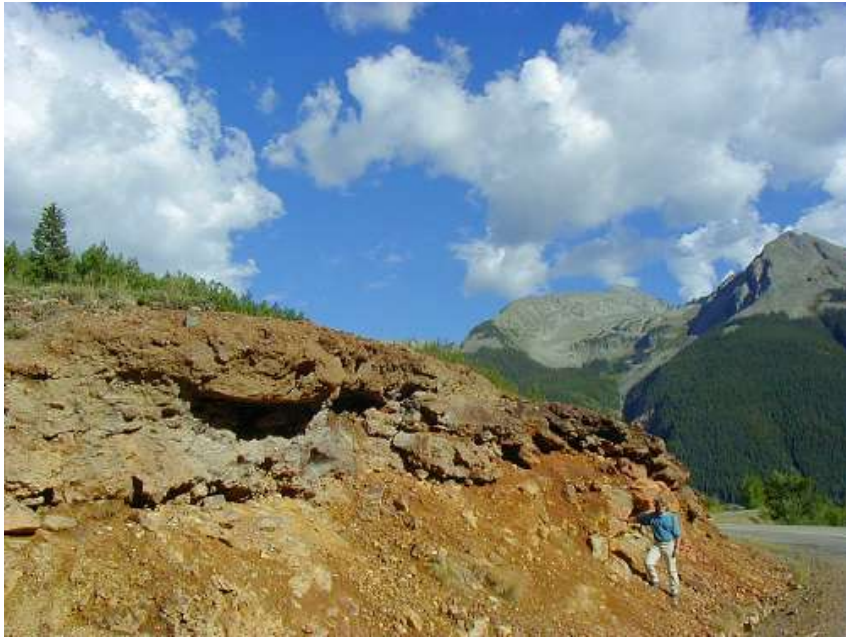
**Ferricrete deposit
in Cement Creek**

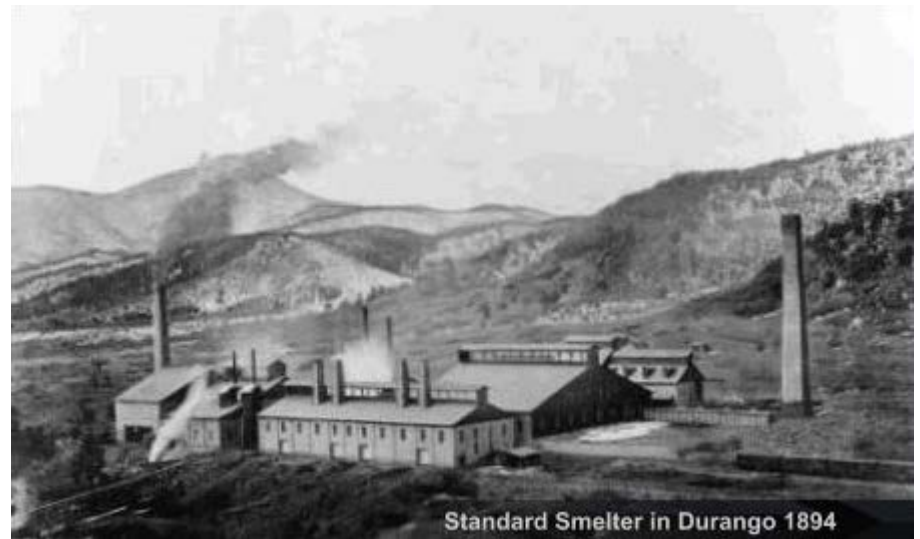
Standard Smelter in Durango 1894

**Durango Smelter/Mill
(lead, vanadium, uranium)**

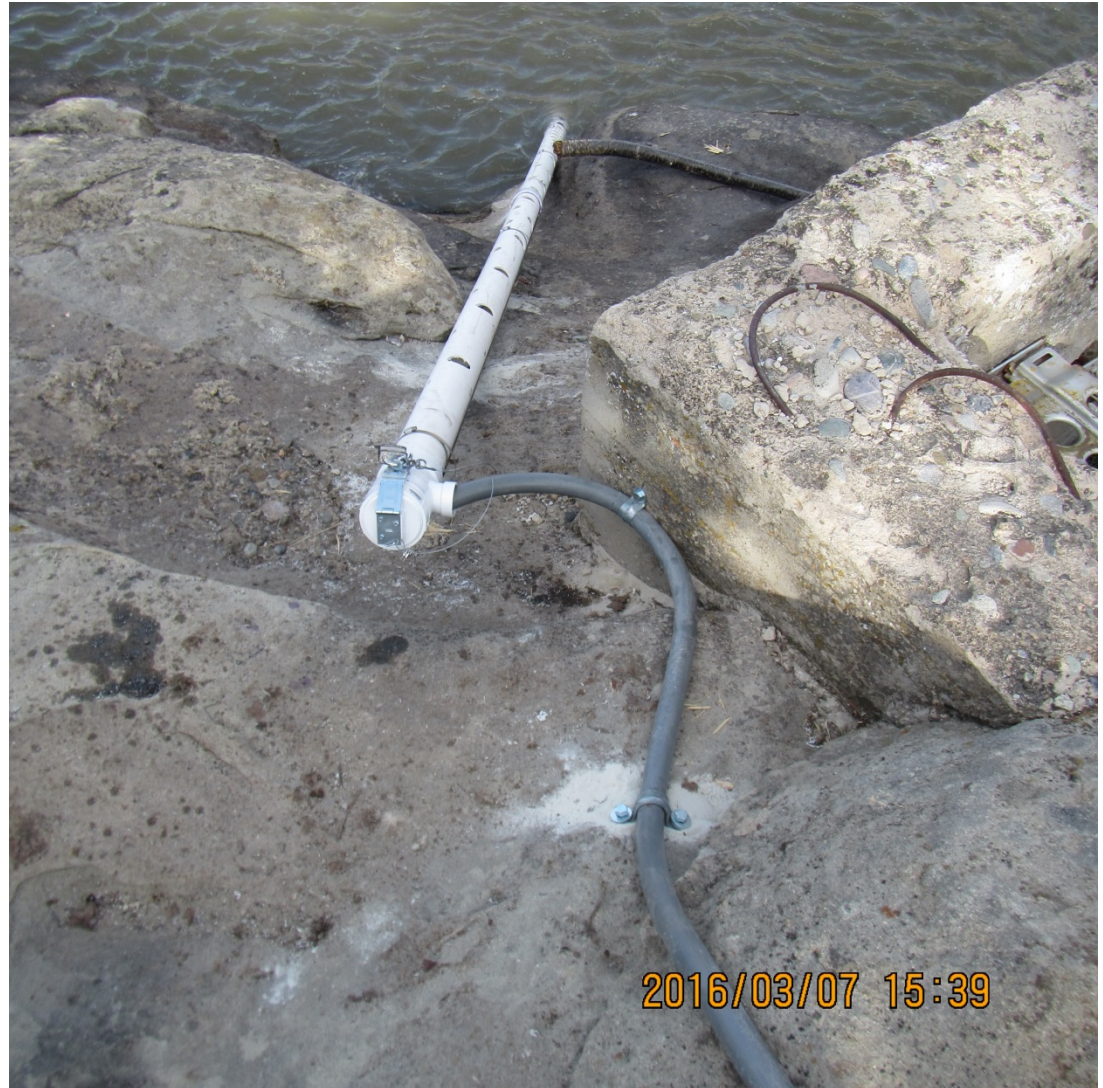
On-Going River Monitoring

1. Sondes in the river for turbidity, pH, specific cond. and temp.
2. Grab samples for lab analysis

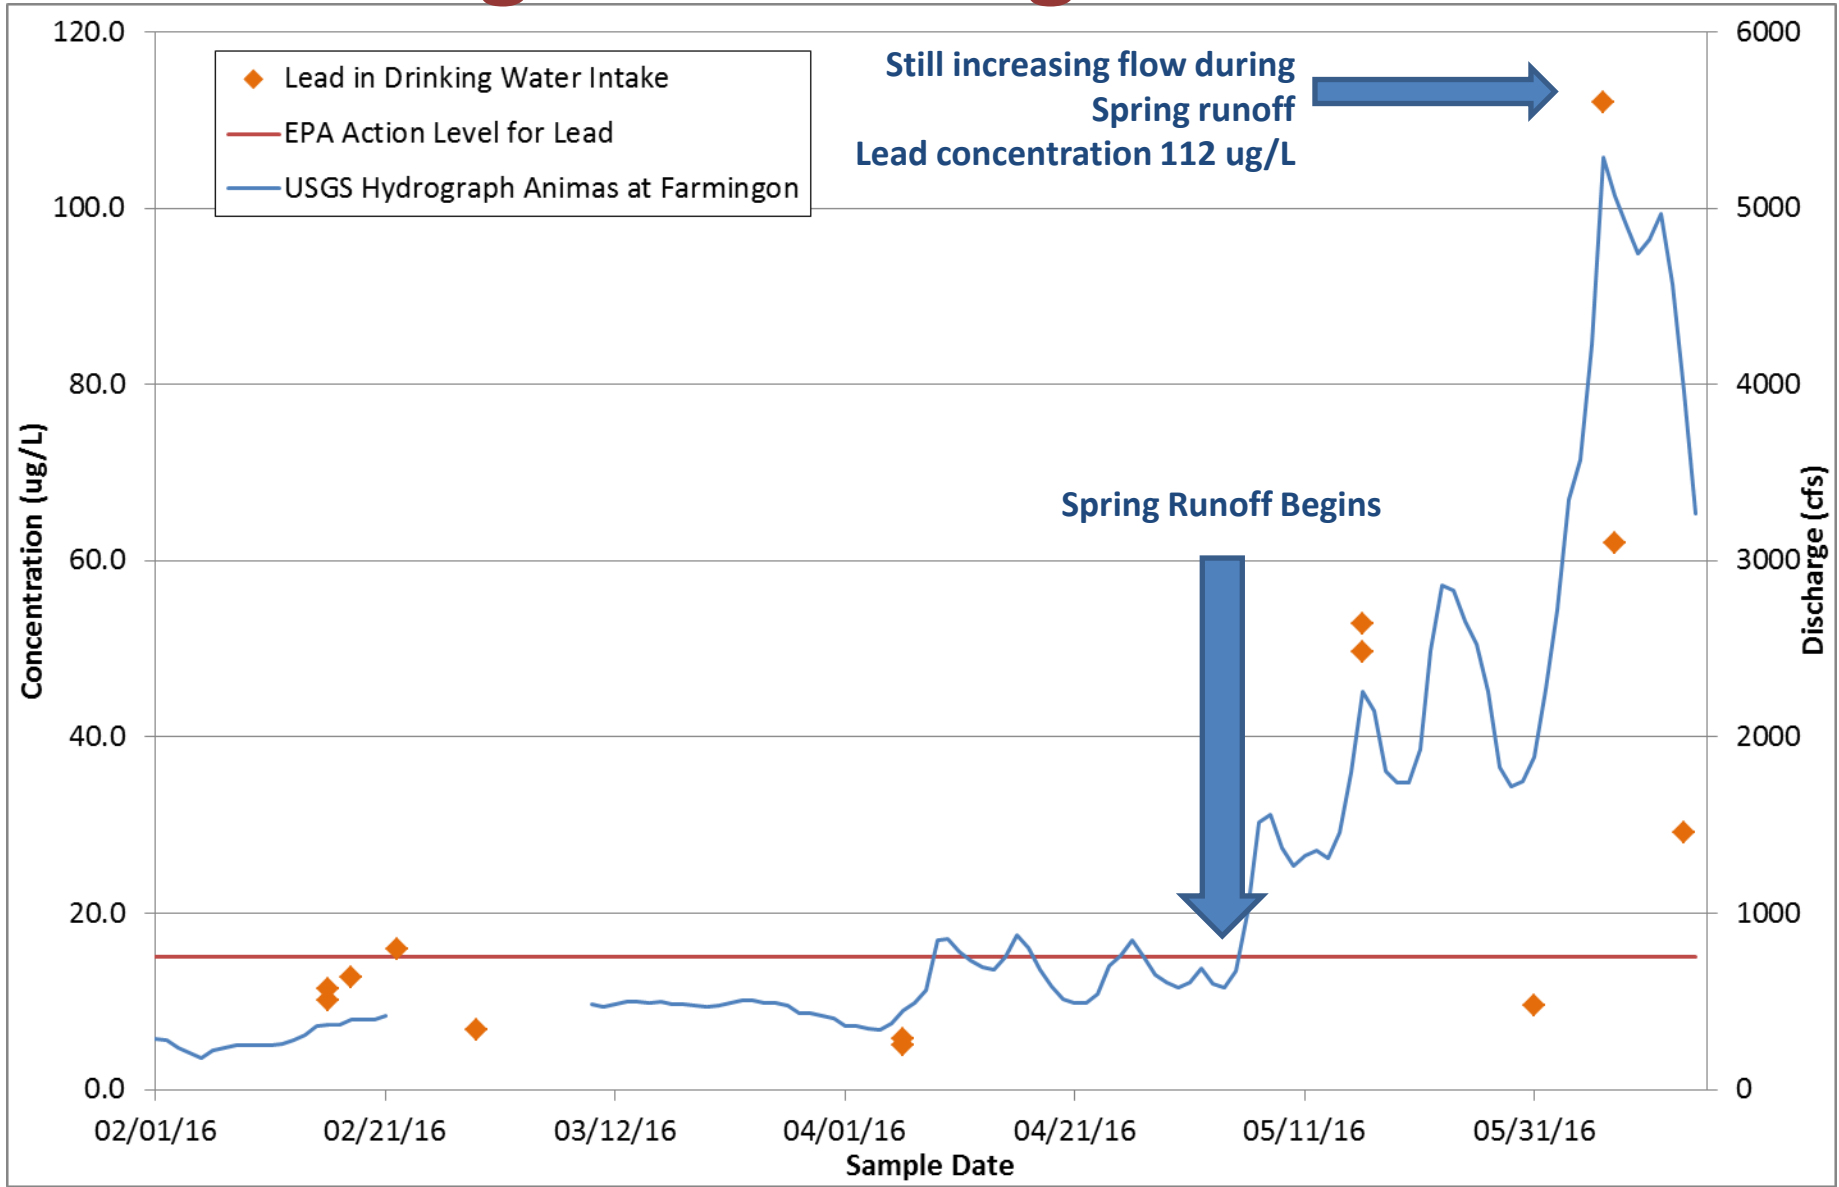
Lead in Animas River at Farmington Drinking Water Intake

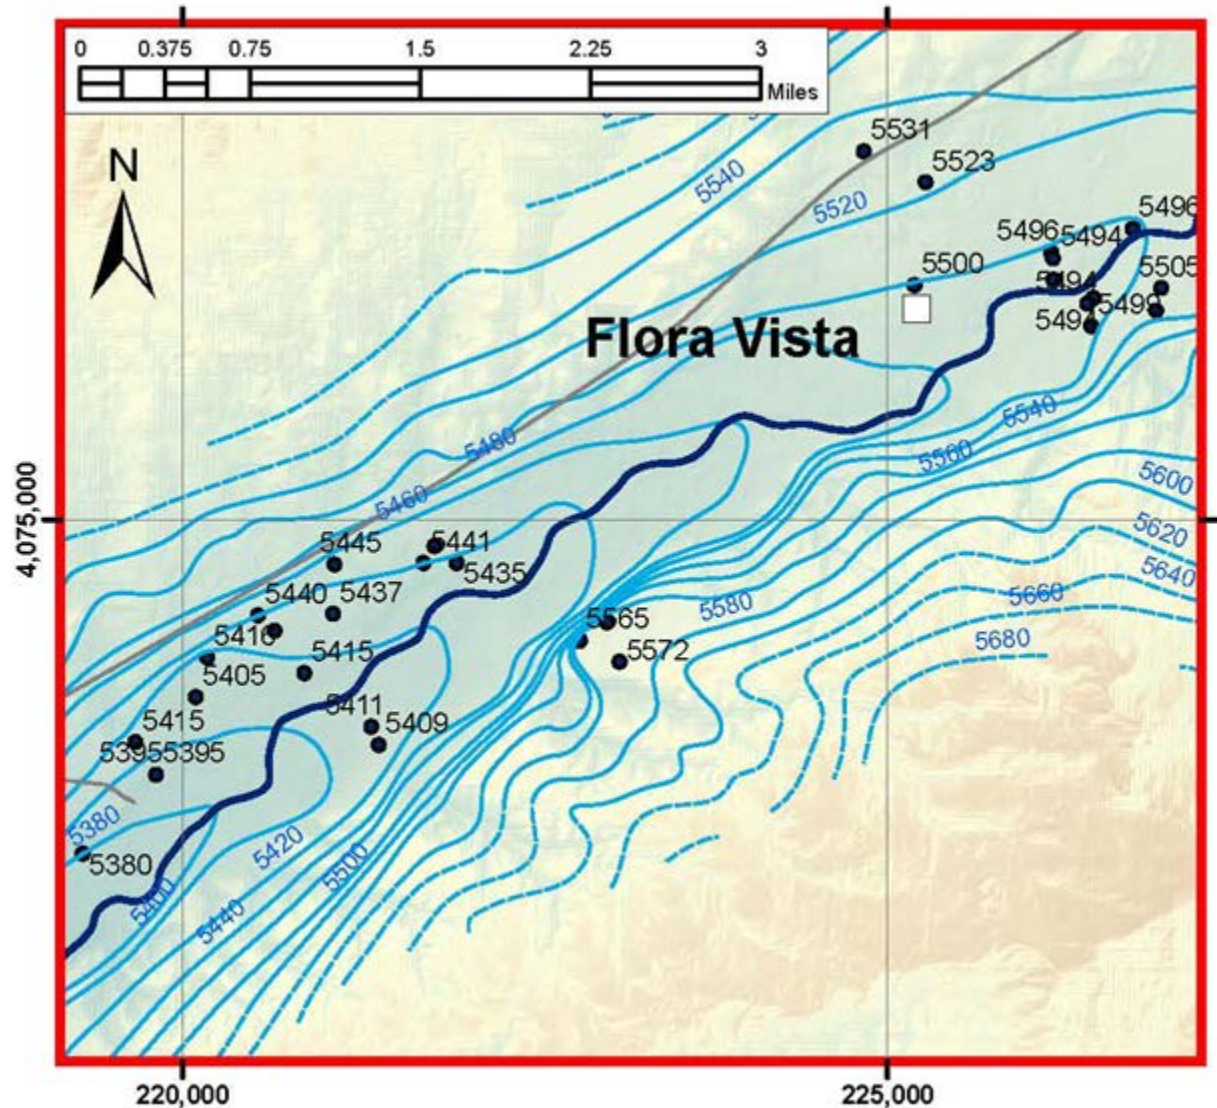
Water Table Mapping

Define
groundwater
flow and aquifer-
river interactions

Water levels in 80
wells measured
seasonally

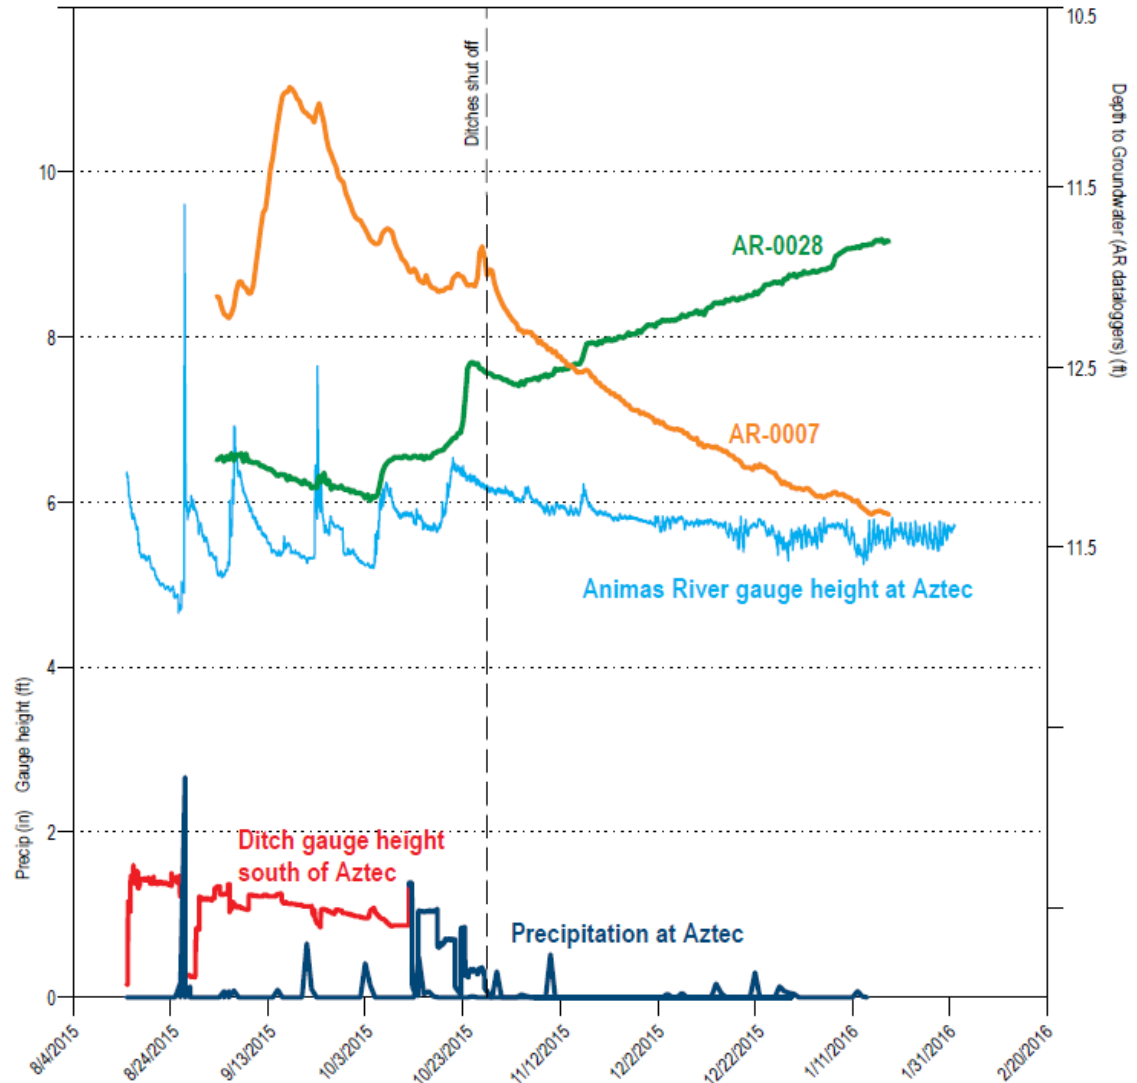
River-Aquifer Interaction

Irrigation ditches have a strong influence on groundwater – sources of recharge.

Data collected underlines importance of continued monitoring of groundwater.

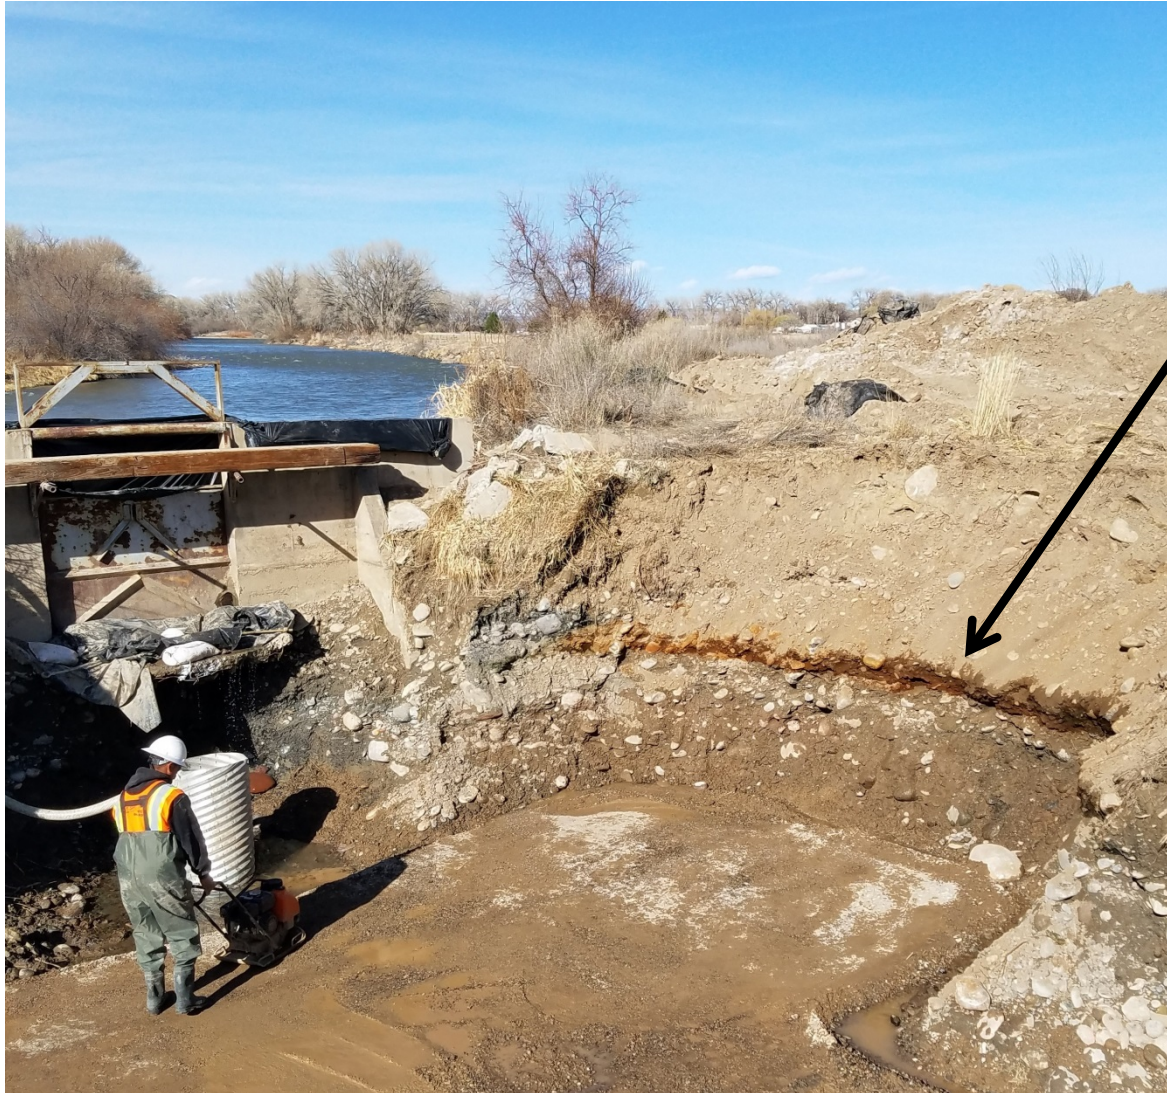
Water-Table Mineralization at Aztec Drinking Water Diversion Channel

2,400 mg/kg lead in mineral layer

Evidence that surface water contaminants entered groundwater near the river

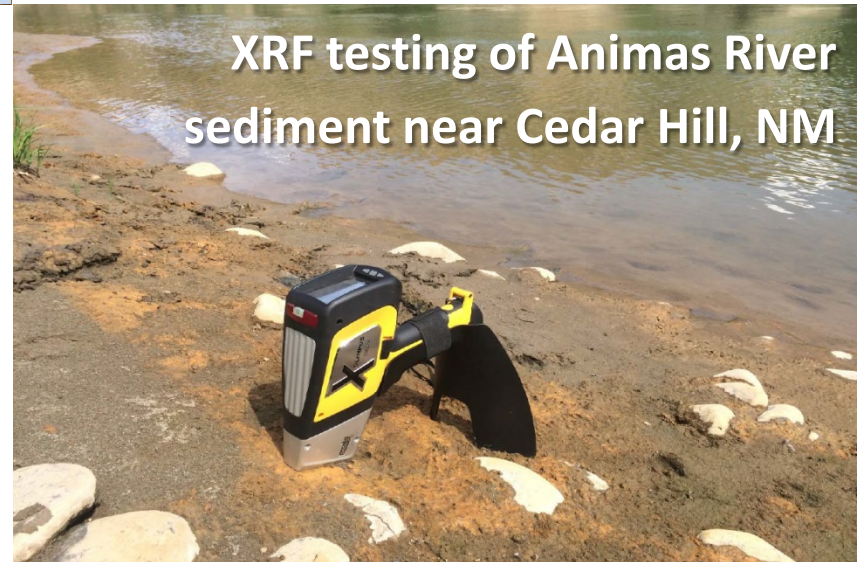
- NMSU and NMED purchased hand-held XRF analyzers
- Soil, sediment and crop tissue sampling for heavy metals

XRF testing of Animas River sediment near Cedar Hill, NM

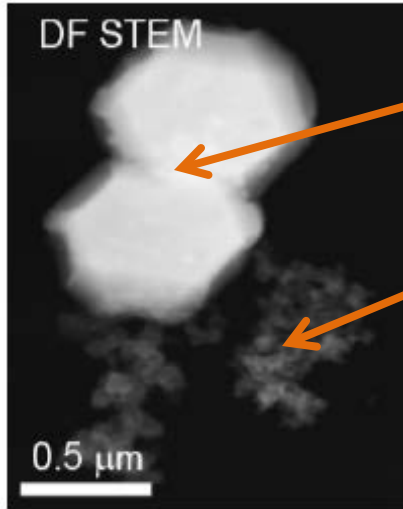
GKM Solids Analysis

Jarosite crystals

Clay-rich material

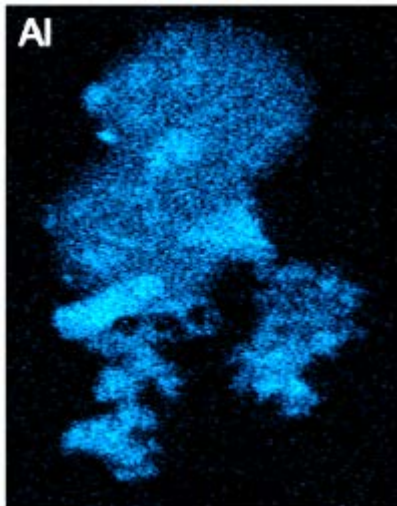
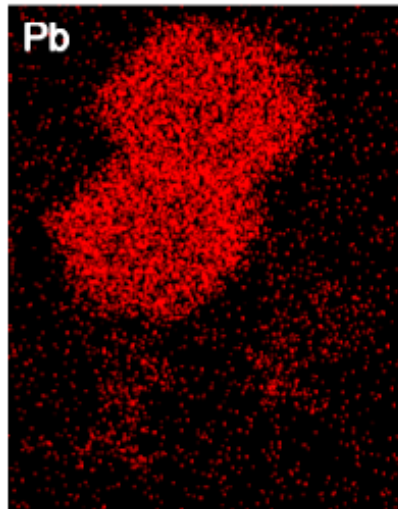
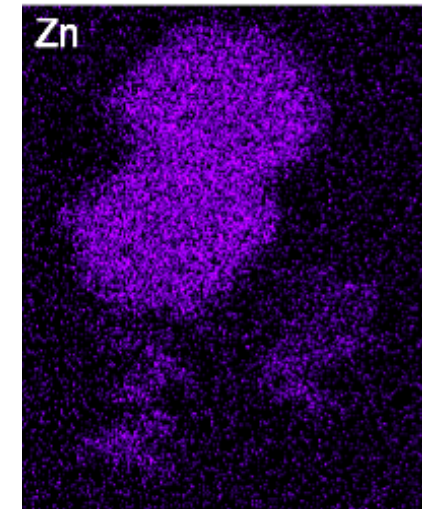
Jarosite grains also contain aluminum, lead and zinc (STEM X-ray)
